Southend-on-Sea  
11<sup>th</sup> October 2013  
Flood Investigation  
Report

Final

March 2015

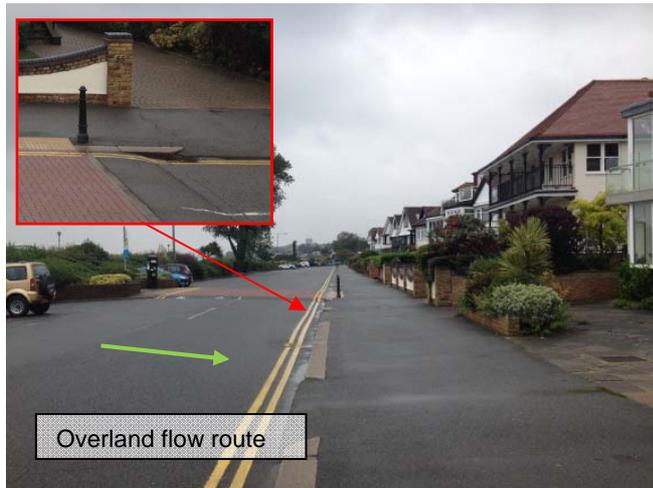
Photograph 3-1: Chalkwell Esplanade (looking west)

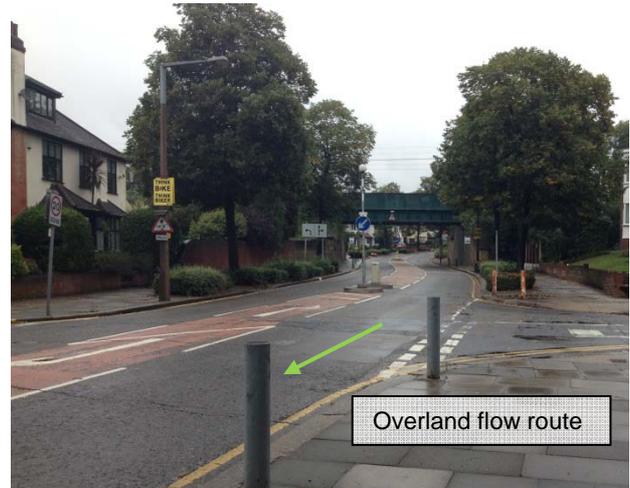
The southern extent of Chalkwell Avenue is relatively flat (Photograph 3-2) following the steep drop from the road to the north. If surface water is unable to enter the road gullies, water would follow the path of the road and accumulate within the area to the south. It should be noted that due to the time of year, road gullies may have been partially blocked by leaf litter, reducing their drainage efficiency.

Photograph 3-2: Chalkwell Avenue (looking north)

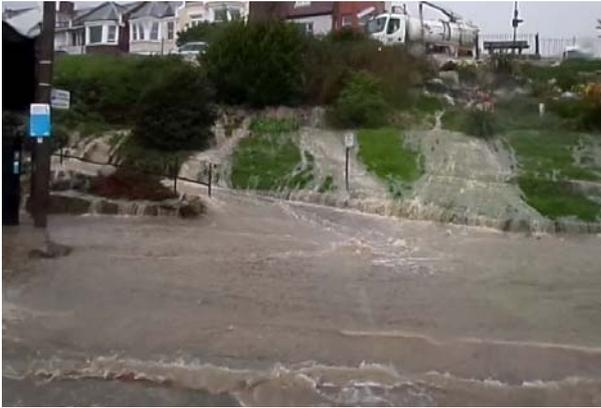
Photographs 3-3 to 3-6 below detail the flooding at Clifton Drive at approximately 16:50 on the 11<sup>th</sup> October, as provided by the SBC Environmental Care Team. These demonstrate the source of flooding to be water surcharging from manholes and gullies within Clifton Drive. The water then runs down the cliff towards Western Esplanade.

Photograph 3-3: Runoff from Clifton Drive (looking north from Western Esplanade)

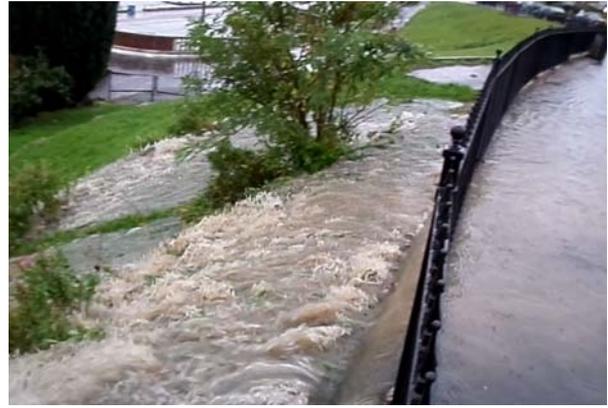
Photograph 3-4: Runoff from Clifton Drive (looking west from Clifton Drive)

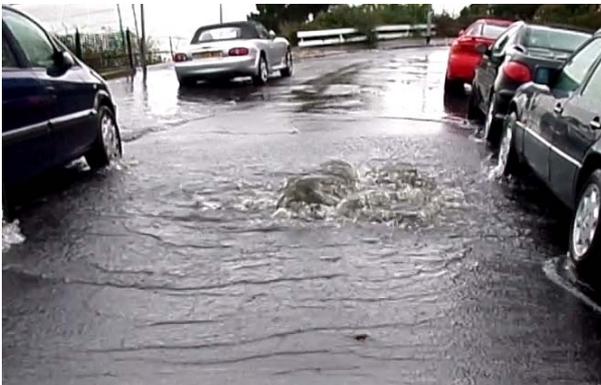
Photograph 3-5: Surcharging manhole at Clifton Drive

Remediation works have been commenced to stabilise the land and the replace the collapsed pipe. However, reports of flooding in September 2014 suggest there are still capacity issues with the network. It is therefore suggested that AW should undertake a survey of the network to determine if the current infrastructure is adequate for managing rainfall in this area.

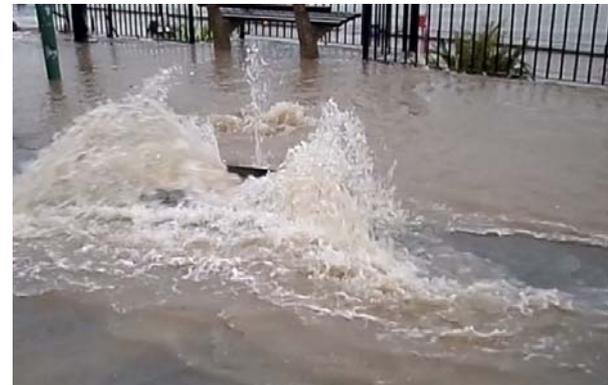
Photograph 3-6: Surcharging gully at Clifton Drive

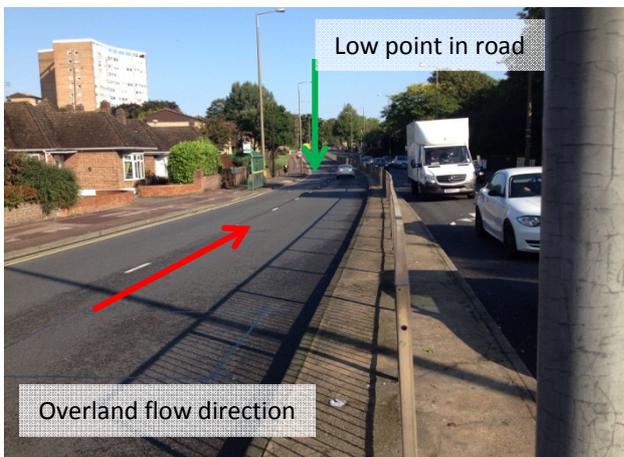
Victoria Avenue (A127) is a major transport route to and from the central area of Southend-on-Sea. The road was observed to flood on the 11<sup>th</sup> October as a result of water overflowing from manholes and gullies. The road flooded previously on the 24<sup>th</sup> August 2013 event.

Photograph 3-7: Victoria Avenue (looking north)

Flooding within this area is likely to be due to the presence of the lower elevation of the road. The source of flooding is considered to be surface water, which is exacerbated by high water levels of the Prittle Brook flood-locking the surface water outfalls.

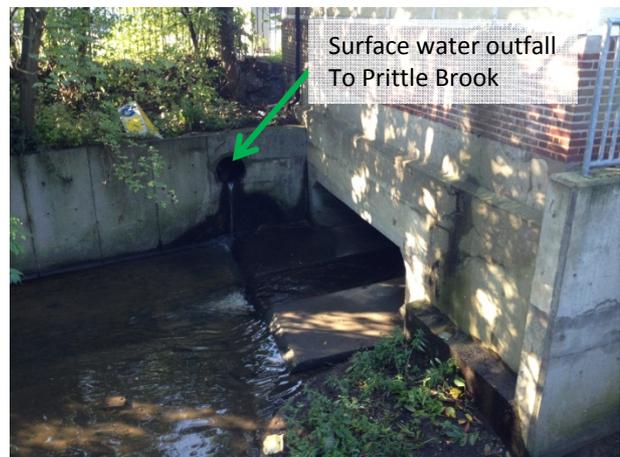
Photograph 3-8: Surface Water to the Prittle Brook

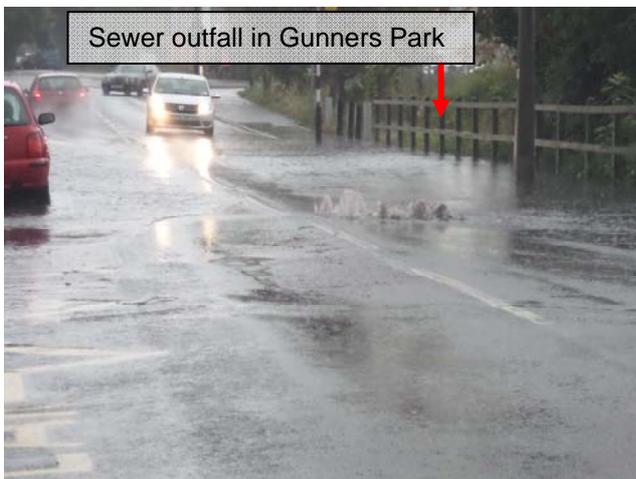
There were two reported incidents of flooding from manholes around Campfield Road and Ness Road, adjacent to Gunners Park on the 11<sup>th</sup> October, as shown in Photographs 3-9 and 3-10.

Photograph 3-9: Flooding from manhole in Campfield Road (picture from SBC Environmental Care team)

In both instances, the surface water networks discharge to the ditches within Gunners Park. As a result of the impeded outfalls and high water levels in the drainage ditch, surface water discharge may have been restricted resulting in water backing up within the networks.

The SBC Environmental Care Team attended the site following the report of flooding. The manhole cover had been broken and lifted at Campfield Road; therefore barriers were placed around the hole to prevent vehicles driving into it.

It is recommended that AW survey the outfall of the drainage networks in this area to ensure there are no blockages that may have influenced the flooding.

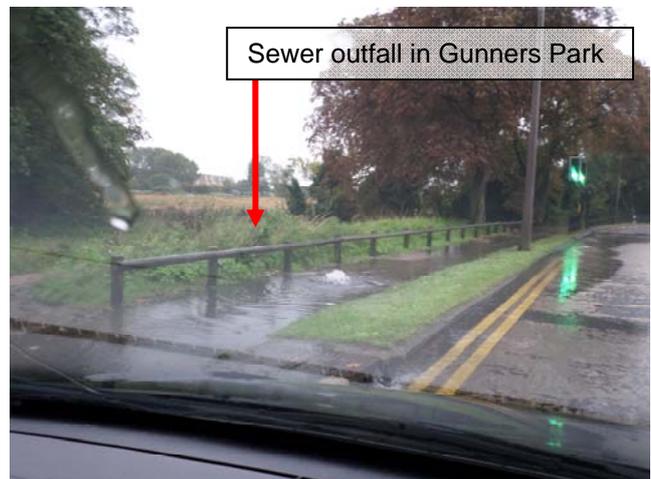
Photograph 3-10: Manhole flooding on footway adjacent to Ness Road (picture from SBC Environmental Care team)

SBC has reported that an examination of the AW outfall at the junction of Ness Road and Church Road, found that the outlet and headwall had partially collapsed within this area, which may have further reduced the capacity of the outfall.
