Southend-on-Sea Borough
Council

Submitted by
AECOM
Scott House, Alencon
Link, Basingstoke,
Hampshire RG21 7PP

Southend-on-Sea 19th September 2014 Flood Investigation Report

November 2015

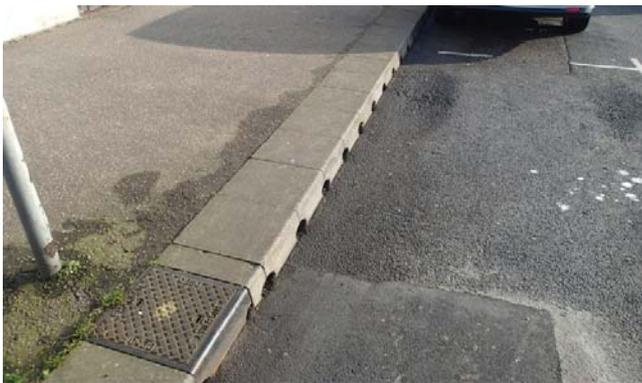
Along Eastern Esplanade and Marine Parade, the roadway is very flat with frequent dropped kerbs. Commercial properties typically have low threshold levels. There is significant drainage infrastructure present along the highway of Eastern Esplanade, as can be seen in Photograph 3-1 and Photograph 3-2.

Photograph 3-1: Multiple inlets in the kerb (Eastern Esplanade)

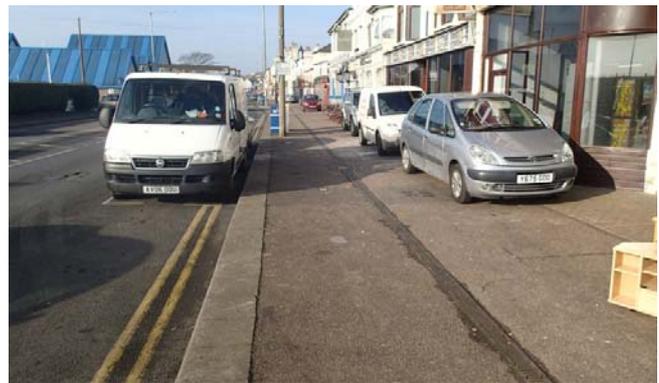
Photograph 3-2: Linear drains in the kerb on Eastern Esplanade looking west

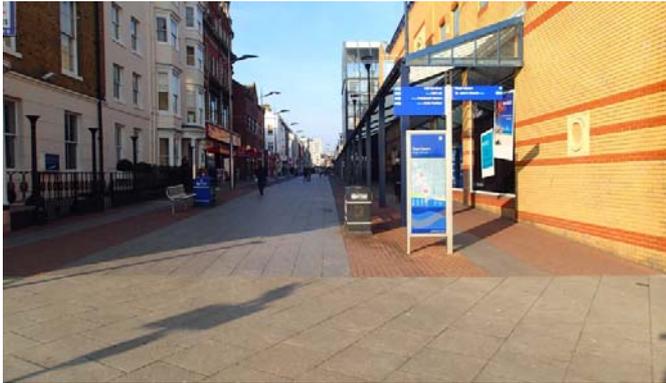
The area of the High Street itself is relatively flat (Photograph 3-3) except for a dip below the railway line. Observations of the gullies and kerb drainage were made during the site walkover. No obvious blockages or constraints were observed other than a small downward dip on Clifftown Parade, which could encourage ponding. Within the pedestrianized area, kerbs were not present, resulting in a flatter surface to assist with access. This results in fewer obstructions to surface water runoff where adjoining roads meet the High Street. With no significant topographical influence, it is likely that flooding around the High Street was due to the high intensity of rainfall, exceeding the drainage capacity of the sewer network.

Photograph 3-3: Flat, pedestrianized area of the High Street, looking North from The Royals Centre

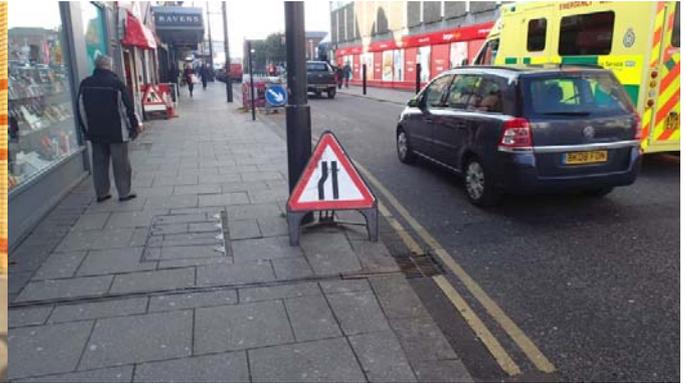
Photograph 3-4: Clifftown Road, looking west from High Street with highway drainage evident

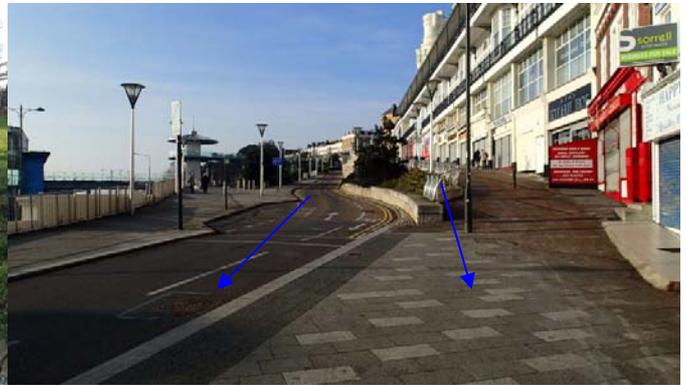
Photograph 3-6: Looking up Pier Hill from Marine Parade

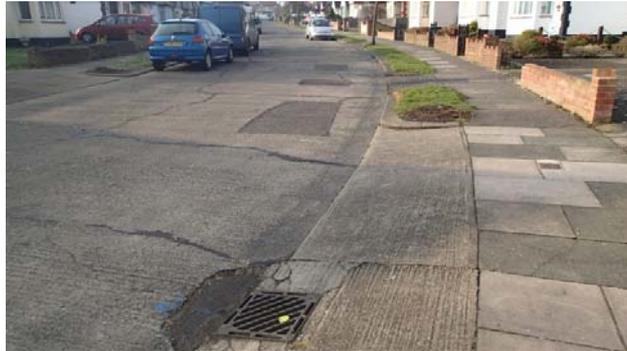
A gully was observed embedded in a dropped kerb above the road level. This appeared largely clear from blockage during the site walkover but would come under significant pressure in a heavy rain storm given the steep slope of the road and surrounds.

Photograph 3-7: Vardon Drive – gully embedded in dropped kerb on the bend in the road.

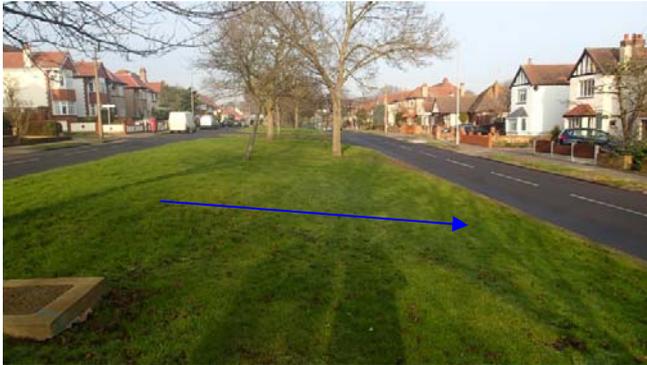
Photograph 3-8: Highlands Boulevard looking north west highlighting the distinct slope in the road towards the affected properties

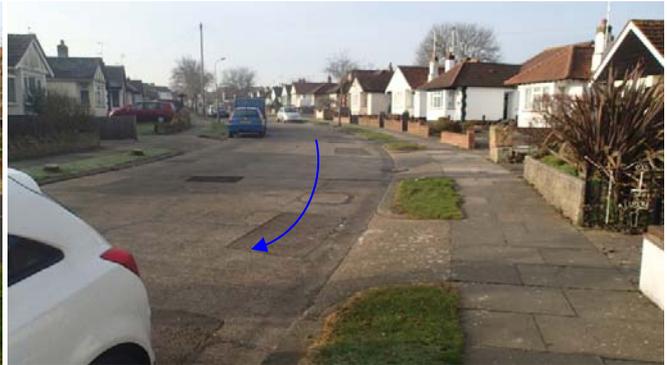
Photograph 3-9: Vardon Drive looking west from lowest point

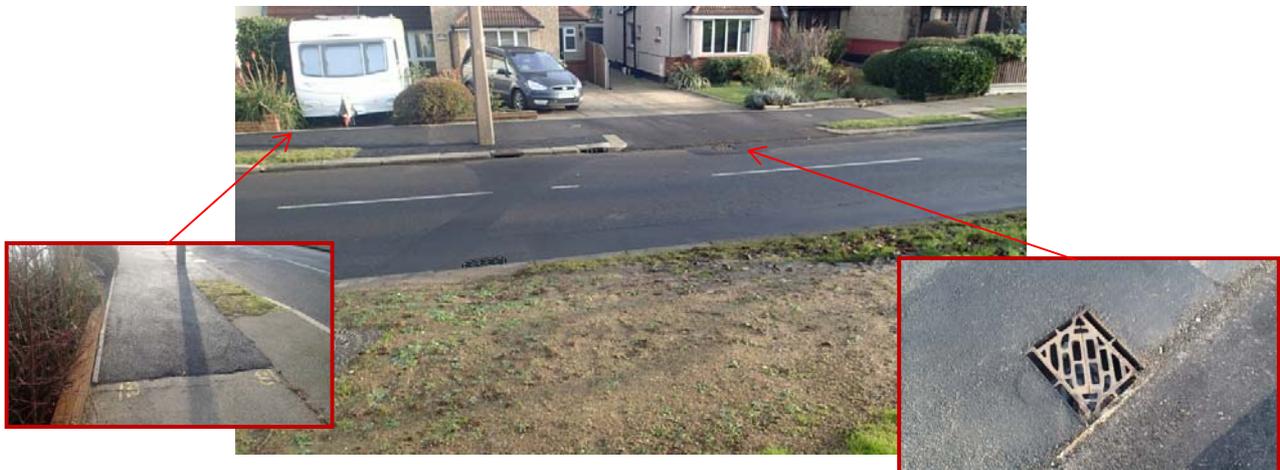
It was noted during the site walkover on 23rd January that highway improvements have been made outside the properties at the lowest point on Highlands Boulevard including a new gully and works to the footway (see Photograph 3-10).

Photograph 3-10: Works evident outside affected properties on Highlands Boulevard including new gully in addition to two others in the kerb and new surfacing to the footway.

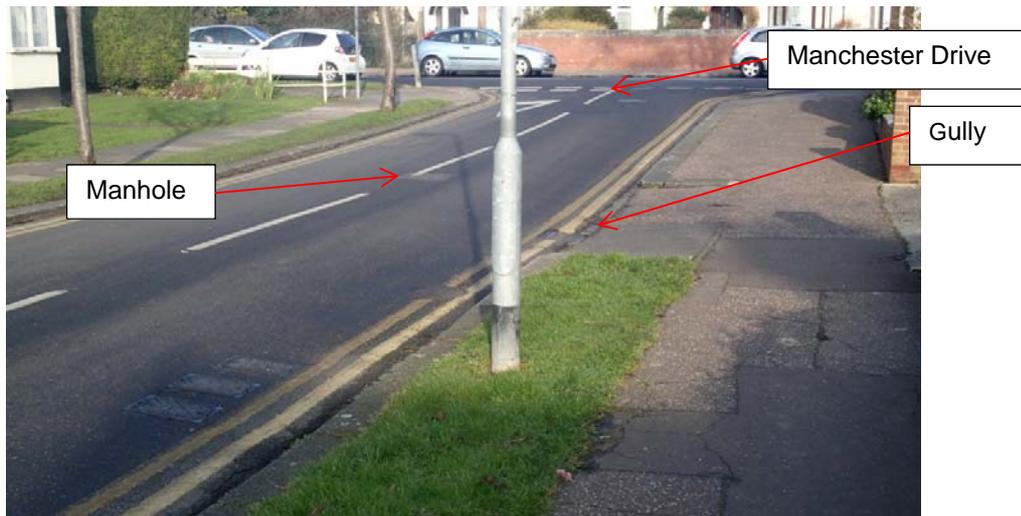
Photograph 3-11: Cricketfield Grove looking north to Manchester Drive. Manholes and gullies present

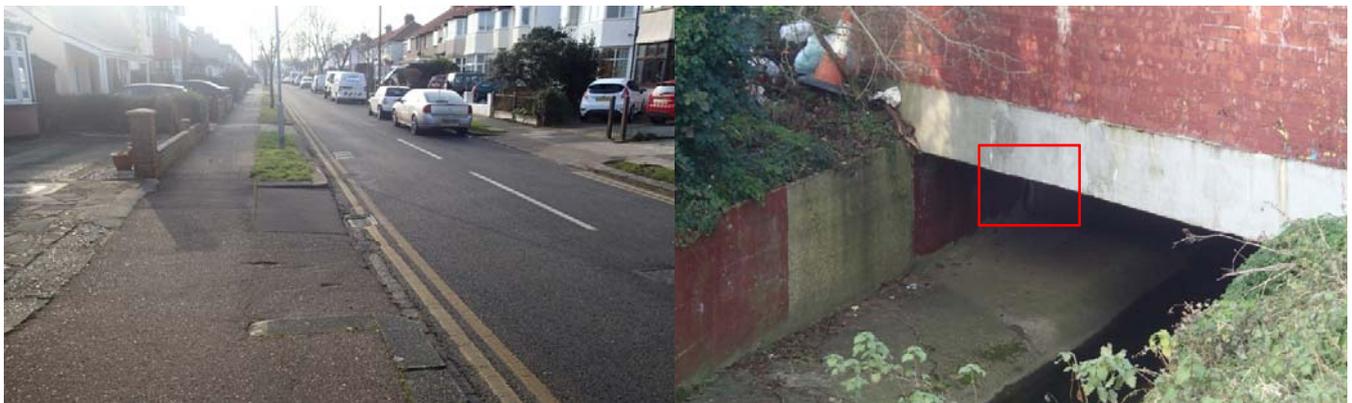
During the site walkover, it was noted that the surface water outfall pipe to Prittle Brook under Manchester Drive was quite low (Photograph 3-13) and therefore likely to get obstructed when the river levels rise. When high river levels combine with a heavy rainstorm, surface water could quickly back up the drainage system into low lying streets like Cricketfield Grove.

Additionally, it has been noted that parked cars along most of the street present obstructions to gully cleaning vehicles. This can prevent the gullies being jetted as regularly as they are scheduled to be and impede effective road drainage. The council contractor's gully cleansing records show 11 gullies were checked on Cricketfield Grove on 12th May 2014. One gully was not cleaned due to a parked car and all the others were running clear at that time.

Photograph 3-12: Parked cars along Cricketfield Grove can obstruct gully cleaning

Photograph 3-13: Outfall pipe into the Prittle Brook observed underneath Manchester Drive

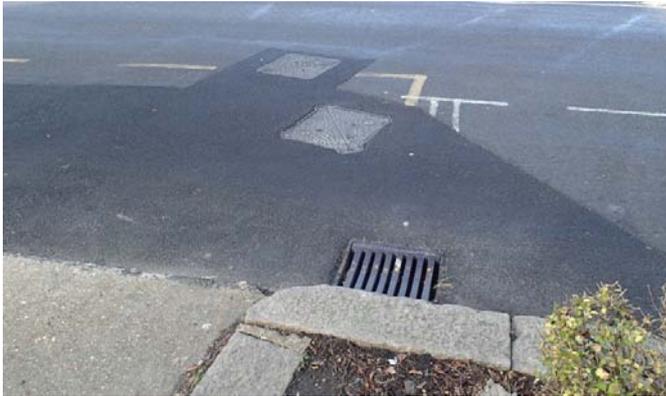
Photograph 3-14: New highway improvements on the Ridgeway observed 23/01/2015

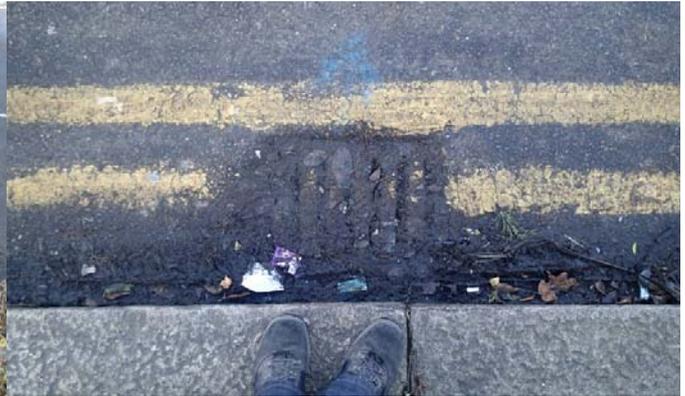
Surface water flooding has repeatedly affected commercial properties on the south side of the Ridgeway where a number of dropped kerbs provide a direct pathway for surface water flowing off the higher ground to the north and east. During the site visit on 23rd January 2015, it was observed that work has been carried out to the drainage system in the highway in front of previously affected properties (Photograph 3-14). It was also noted that a number of the existing road gullies had become quite silted up (Photograph 3-15).

Photograph 3-15: The Ridgeway, some road gullies appear heavily silted up on 23/01/2015

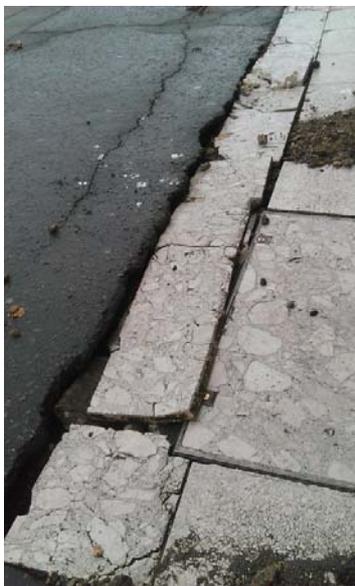
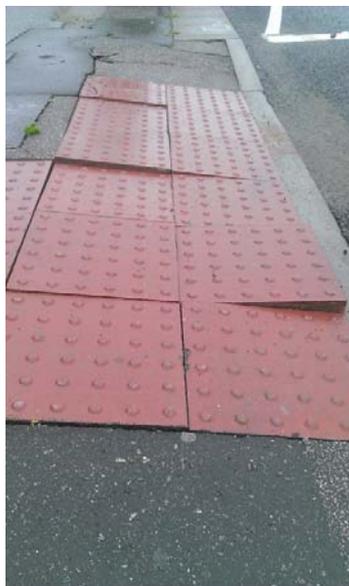
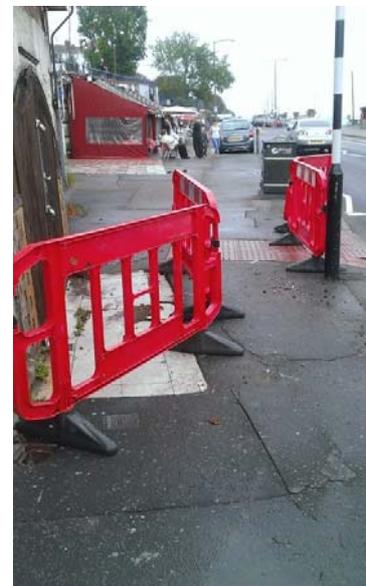
Two incidents were reported in this area on 19th September 2014; one incident of sewer surcharging in a residential property and one of damage to the carriageway (Photograph 3-16).

Photograph 3-16 a, b & c: Damage to the carriageway on Western Esplanade caused by flooding on 19th September 2014

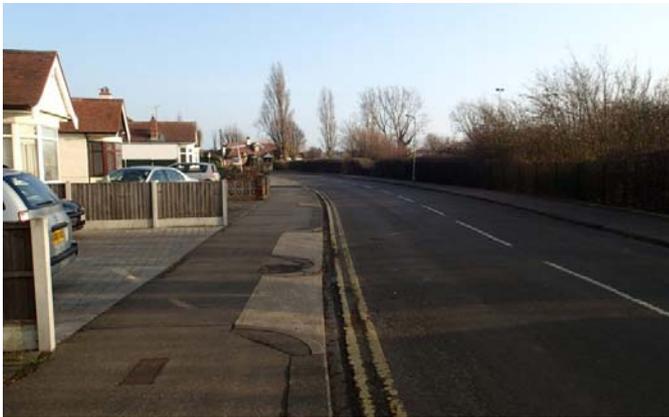
Photograph 3-17 Northumberland Crescent looking east

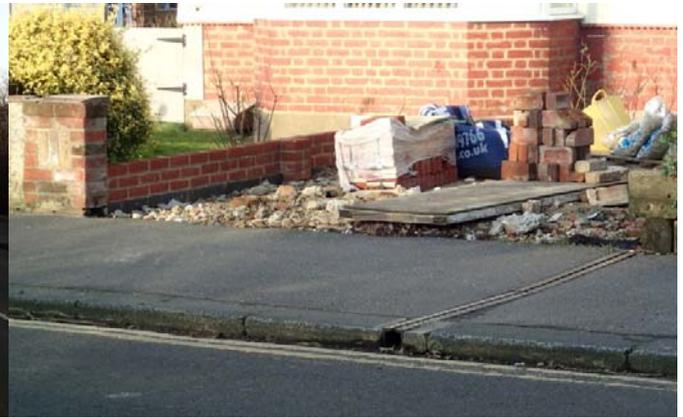
Photograph 3-18: Residents affected by flooding have installed a new boundary wall as property level protection

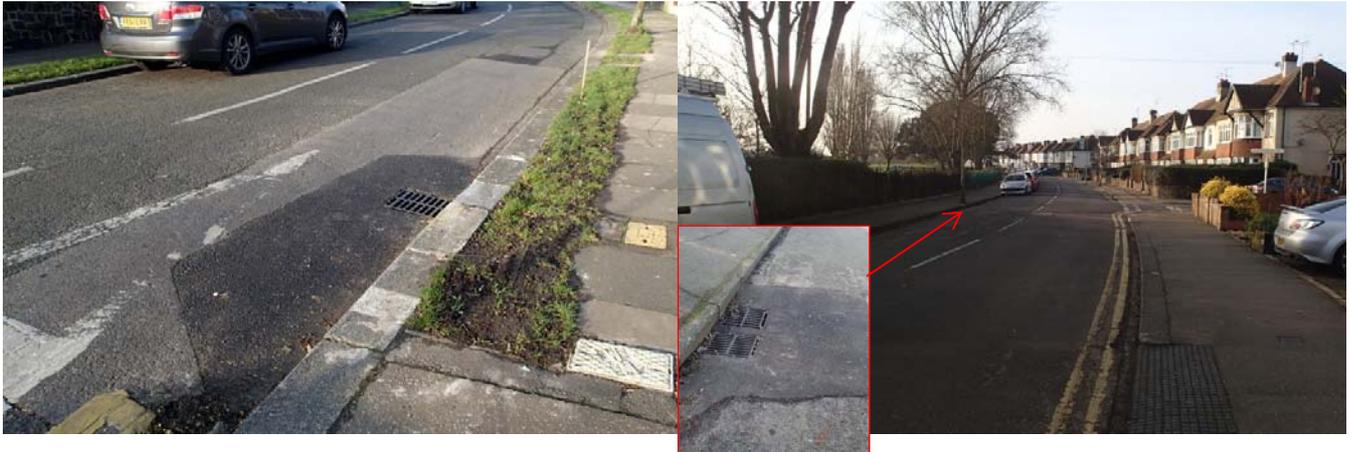
Photograph 3-19: New Highway drainage work observed on 23/01/15 outside affected property on Huntingdon Road

Photograph 3-20: A double gully is present in Northumberland Crescent opposite junction with Huntingdon Road

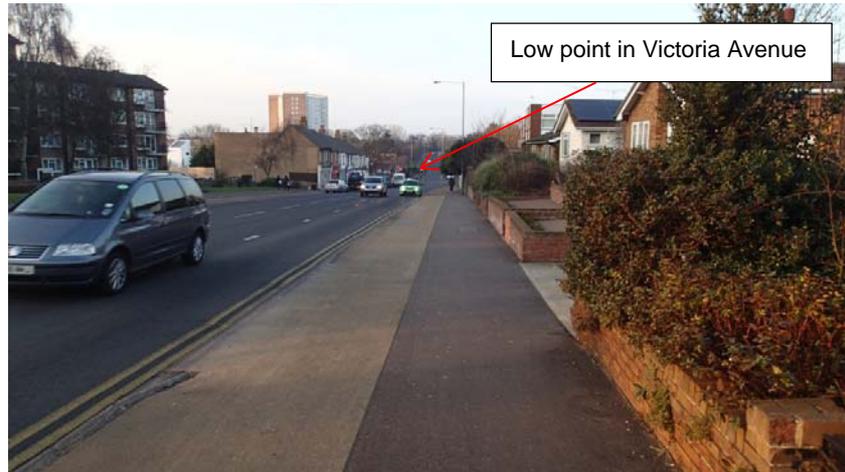
Photograph 3-21: Victoria Avenue looking north towards junction with Fairfax Drive

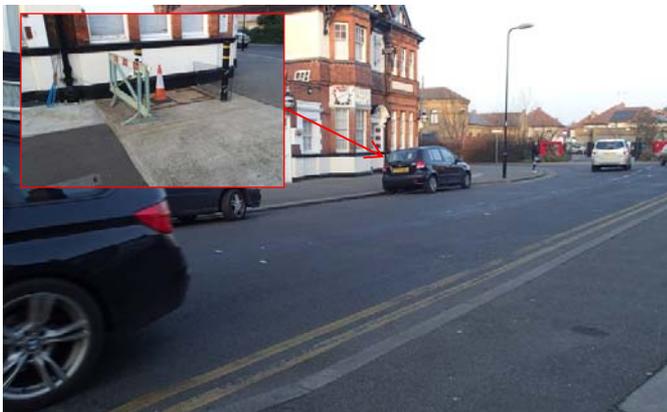
During the site visit it was observed that there was very little drainage present in the road around a reported incident site at North Road, and the camber of the road slopes slightly north where there are a number of dropped kerbs providing a flow path for any accumulating surface water. The public house on the corner has a basement cellar which would be vulnerable.

Photograph 3-22: North Road looking east. Low kerbs and minimal drainage observed. Insert of entry to basement cellar.

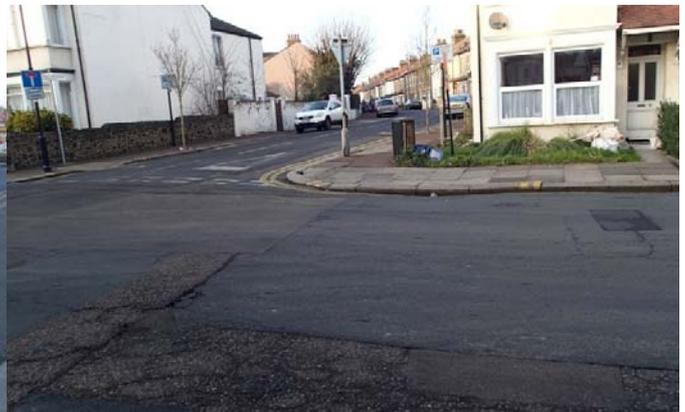
Photograph 3-23: Corner of Harcourt Avenue and Colchester Road looking north
