The London Tilbury and Southend Railway constructed the first railway to Southend, which reached Southend Central in 1856. This ran along the coast from Leigh on Sea to the outskirts of what is now Chalkwell, before continuing slightly further inland to reach its original terminus.

We will now focus on the southern approach ramp, the Council owned structure, which we shall henceforth refer to as Chalkwell Ramp.

## Detailed Inspection

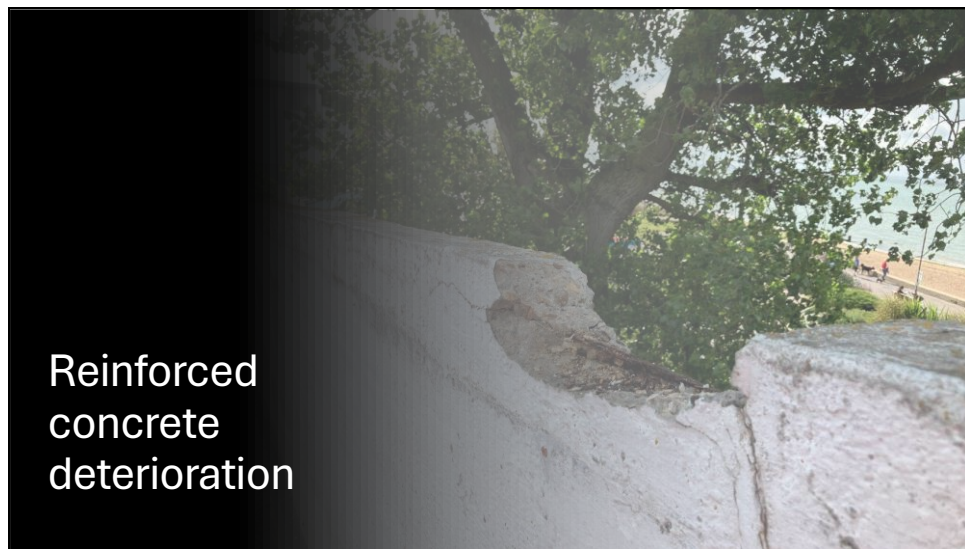
Interpreting the conclusions from this report, The testing covered common phenomena that cause the deterioration of reinforced concrete. The summary above showed that in all respects, the phenomena had reached levels beyond which corrosion of the reinforced concrete was likely to occur, generally by significant values. It is therefore highly likely that at that time, the hidden reinforcement was already subject to the onset of corrosion, which in the intervening period, will have worsened.

These are the oldest records the Council has on file regarding the condition of the structure, however based on the data provided in the report, it is clear that defects related to the reinforced concrete deterioration will likely have already been present for some time.

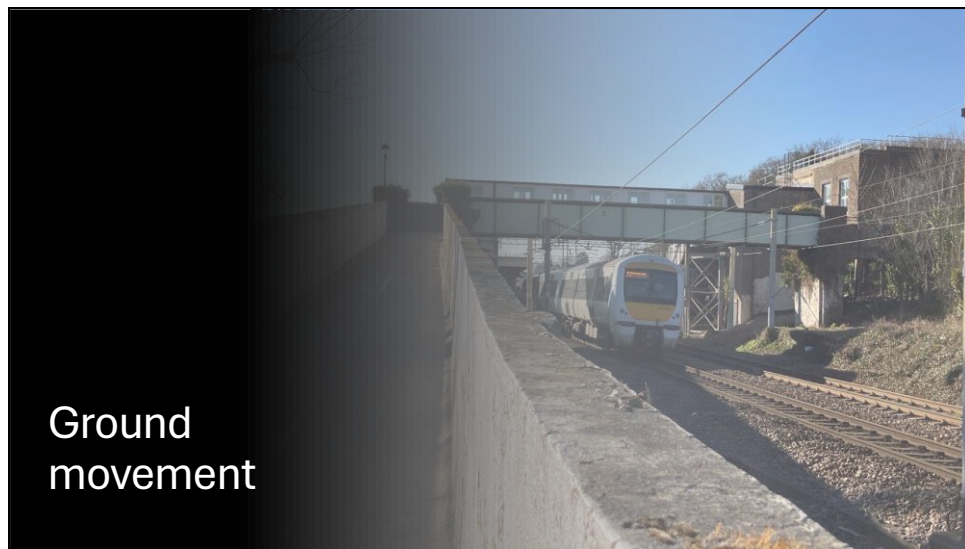
The structure is shown by the record drawings to have been constructed off shallow foundations, presumably bearing onto the clay strata that has been proven to underlie this site through separate investigation. Clay as a cohesive material is susceptible to volume change, which is determined by its water content, itself affected by seasonal factors and the presence of vegetation.

The ground levels around the structure also appear to have been built up somewhat relative to when the structure was constructed, increasing the lateral forces acting on certain parts of the structure.

The structure shows various signs of being affected by ground movement, with structural movement and distortion noted in various planes. It is thought some of this movement happened relatively early in the structure's life, as some distortion can be seen in early photos of the structure.

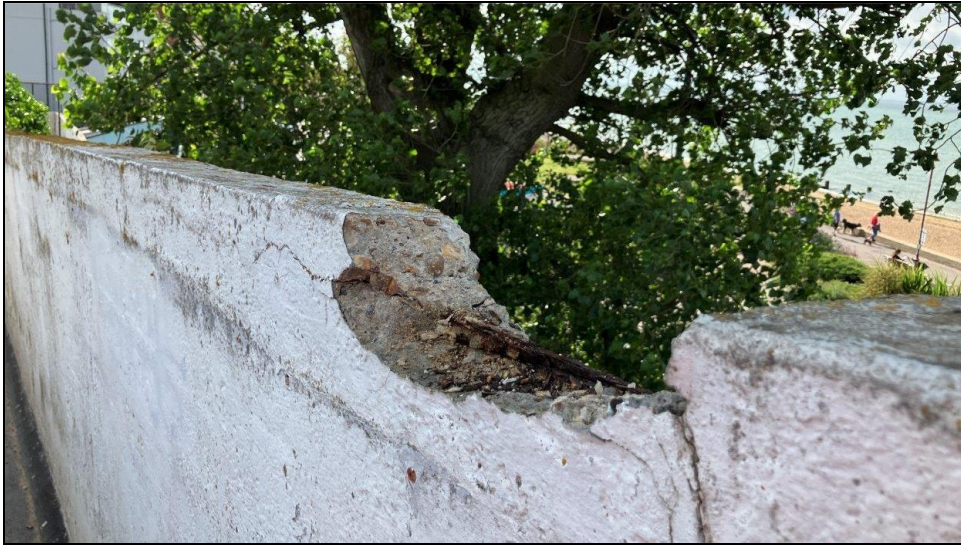
This view shows an area from which a substantial segment of loose concrete at height was removed from a parapet. Note the severely corroded reinforced exposed by the missing concrete.

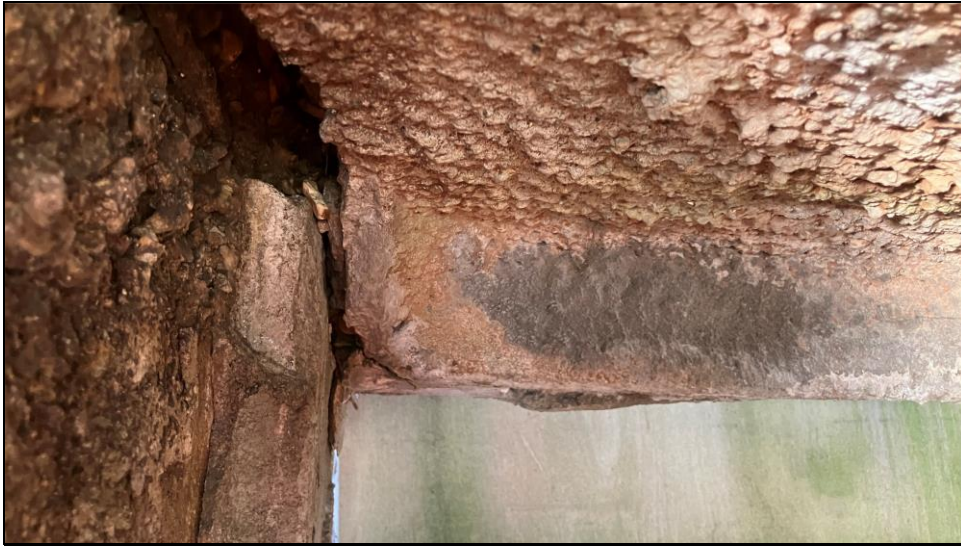
This view shows the almost complete separation of one length of ramp from its supporting column. The large fracture allow the ingress of water, exacerbating deterioration and corrosion of reinforcement here.

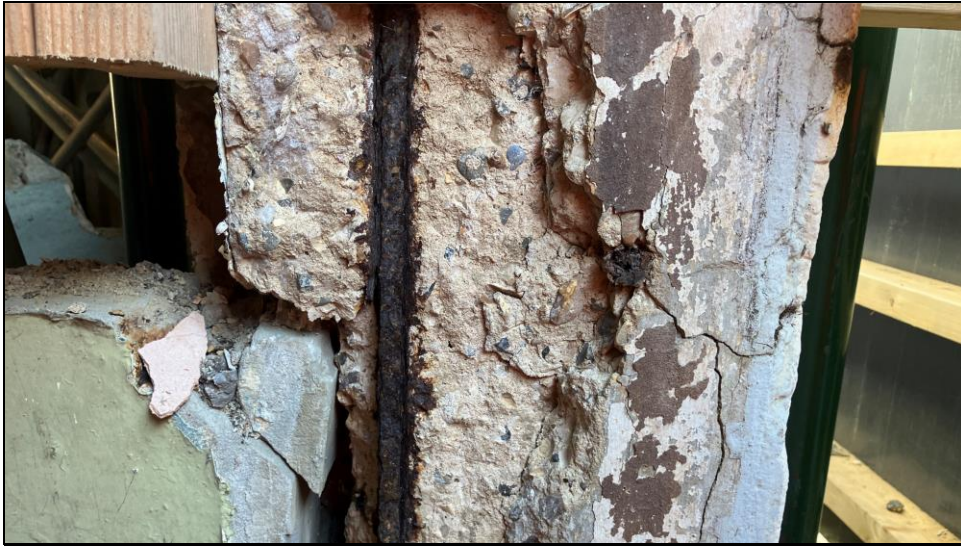
Here we have one of the main supporting columns showing advanced signs of deterioration and effectively experiencing the onset of failure, with heavy concrete loss, buckling of corroded reinforcement and complete loss of link reinforcement.

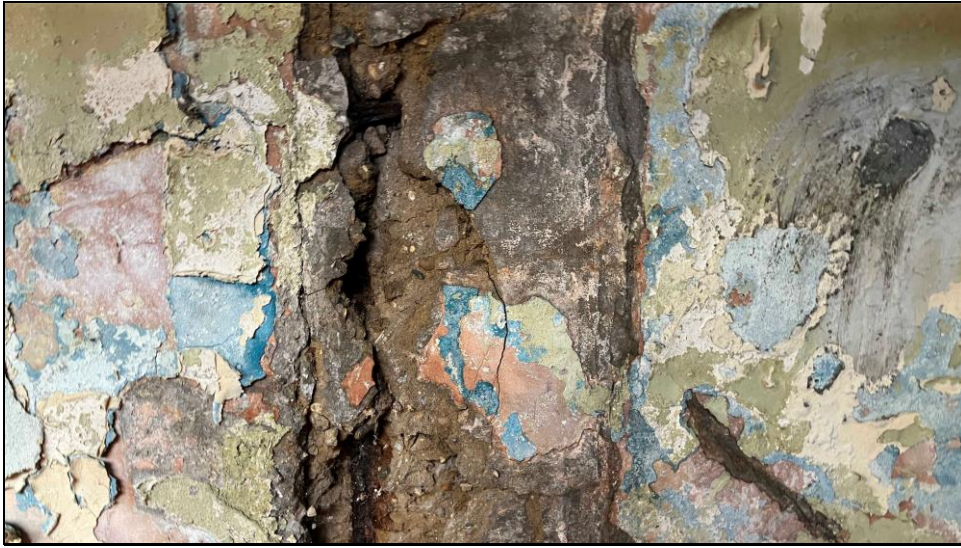
The central area of this view shows a supporting column, with the areas either side being walls retaining railway property, at higher level beyond. Note how these walls have 'punched' past the face of the column and the generally very poor condition of the concrete per se.

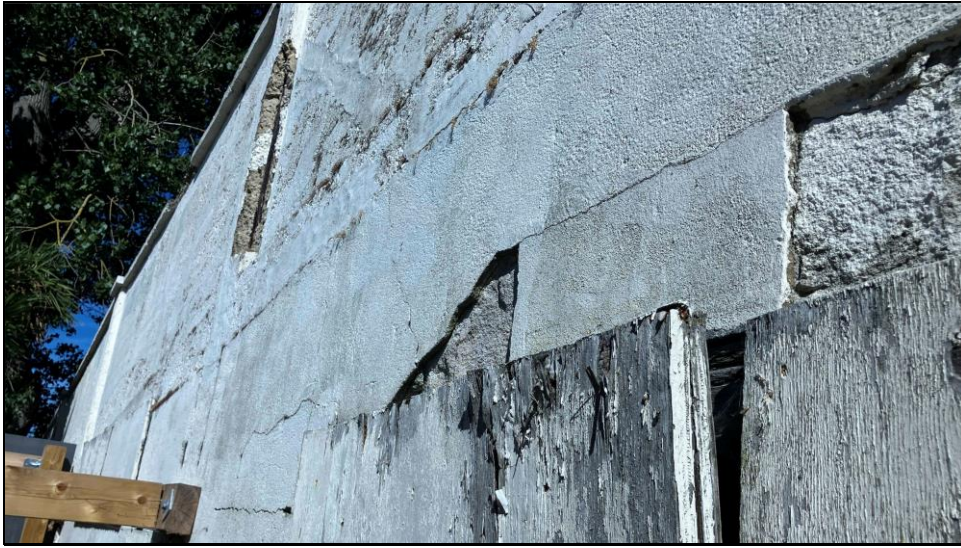
Example view of further loose concrete at height removed from parapets and the unstable defective infill walling beneath the seaward side of the ramp.

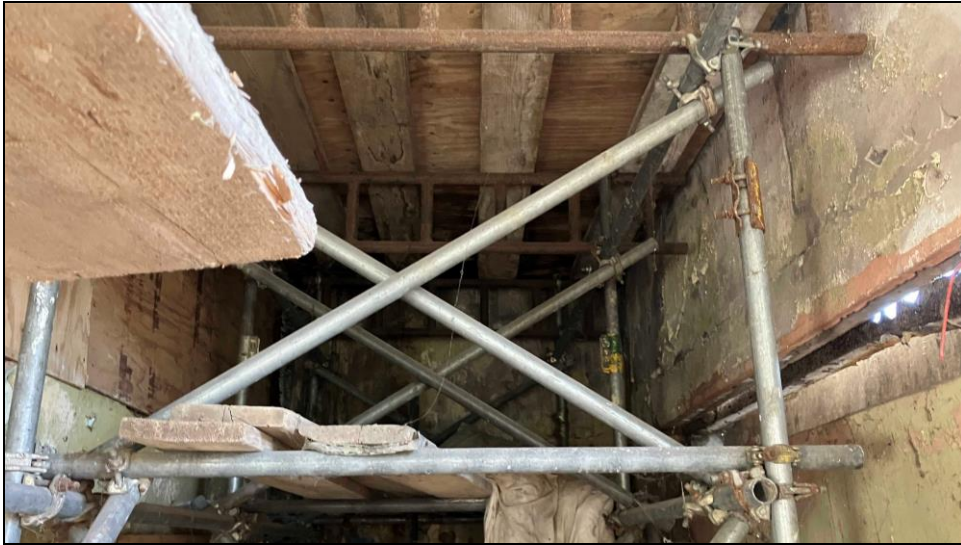
Very poor condition in general within enclosed rooms beneath the ramp, with longstanding temporary works effectively no longer possible to safely maintain and themselves nearing life expiry.
