Southend-on-Sea  
11<sup>th</sup> October 2013  
Flood Investigation  
Report

Final

March 2015

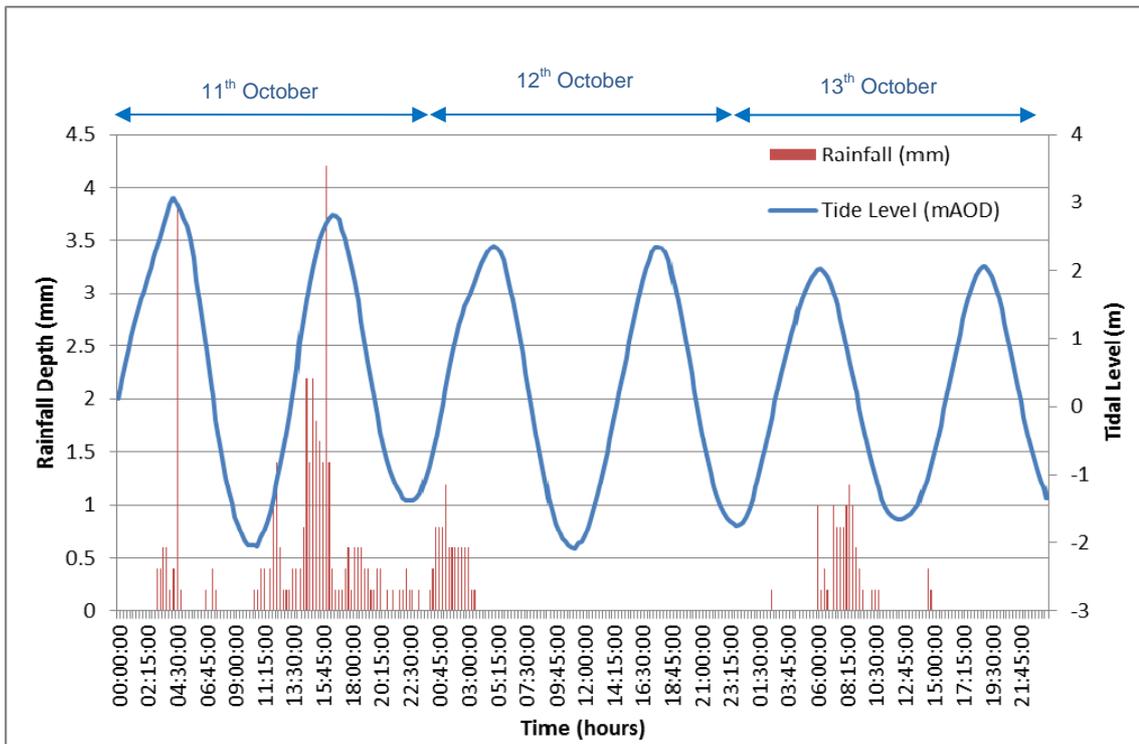
Figure 2-1: Recorded rainfall (mm) at Southchurch Park and tide levels at Southend Pier from the 11<sup>th</sup> to 13<sup>th</sup> October 2013.

The EA tipping bucket rain gauge located in Southchurch Park (Ordnance Survey National Grid Reference: 589992, 184988) recorded 38.6 mm of rain to have fallen between 03:00 to 23:15 on the 11<sup>th</sup> October. At the peak rainfall intensity, 37 mm of rain fell over 17.75 hours (between 03:00 – 20:45), with 4.2 mm falling within 15 minutes at 16:00. This is plotted in Figure 2-1. By comparison, the average monthly rainfall for this area in October is approximately 59.9 mm.

The tidal levels recorded at Southend Pier are also shown in Figure 2-1. The spring tide was recorded on the 11<sup>th</sup> October at 04:15, reaching a level of 3.07m AOD. This coincided with the first period of heavy rainfall of 3.8 mm at 04:30. The second high tide, recorded at 16:30 again coincided with the main rainfall event, where the peak intensity of 4.2 mm was recorded at 16:00 on the 11<sup>th</sup> October.

The 13<sup>th</sup> October rainfall commenced at 06:00 am, coinciding with the high tide of 2.07m at 06:00 am.

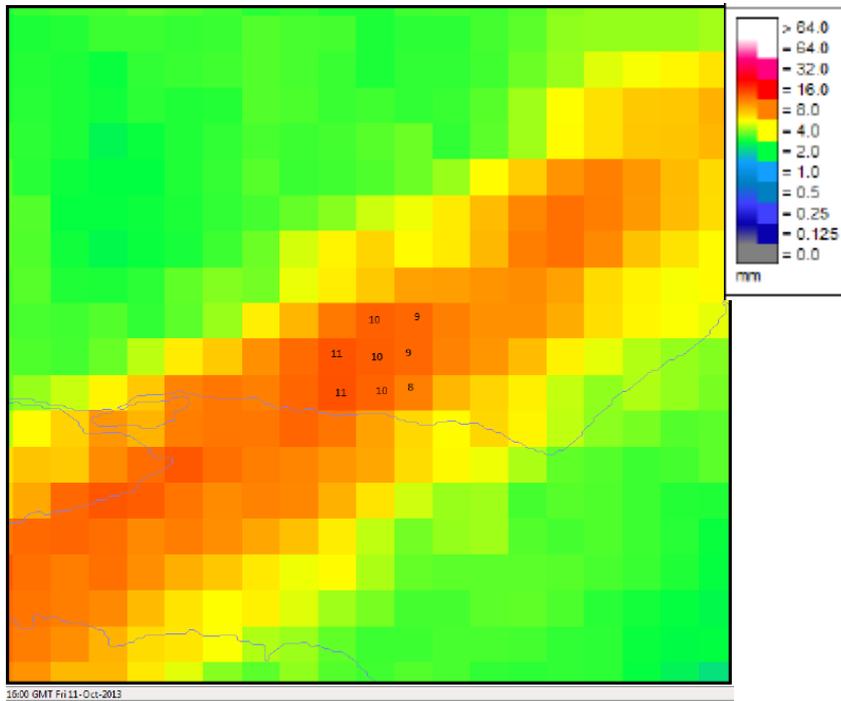
Radar data supplied by the Environment Agency shows a peak rainfall intensity of 3.4 mm to fall at 15:15, 2.6 km to the west of the Southchurch park rain gauge. Between the times of 03:00 to 23:15, a rainfall depth of 32.4 mm was recorded. The total rainfall between 15:00 and 16:00 is presented in Figure 2-2a. This shows a band of intense rainfall passing across Southend-on-Sea in a north westerly direction with a total of 11mm of rainfall falling within the hour.

- a) Environment Agency Radar imagery showing the 60 minute accumulation between 15:00 and 16:00 on the 11<sup>th</sup> October 2013. Rainfall depths are in mm.

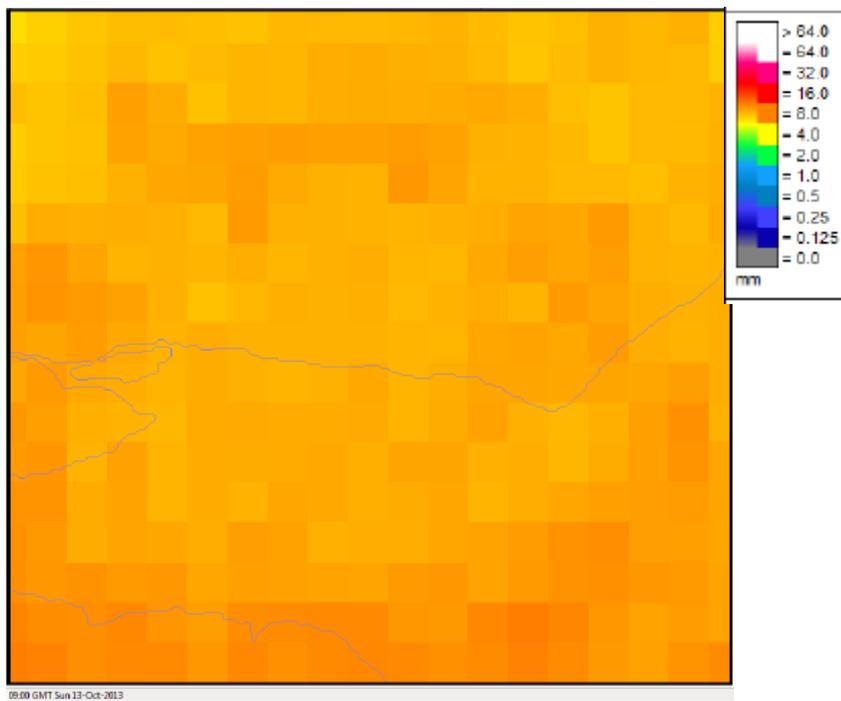
Radar data for the 13<sup>th</sup> October recorded a peak rainfall of 2.1mm to be recorded over 15 minutes at 08:15 at Delaware Road, approximately 2.5 km to the east of the Southchurch Park rain gauge. The Radar imagery, Figure 2-2b, shows the rainfall on this occasion to be widely spread across the Borough.

- b) Environment Agency Radar imagery showing the 60 minute accumulation between 08:00 and 09:00 on the 13<sup>th</sup> October 2013. Rainfall depths are in mm.

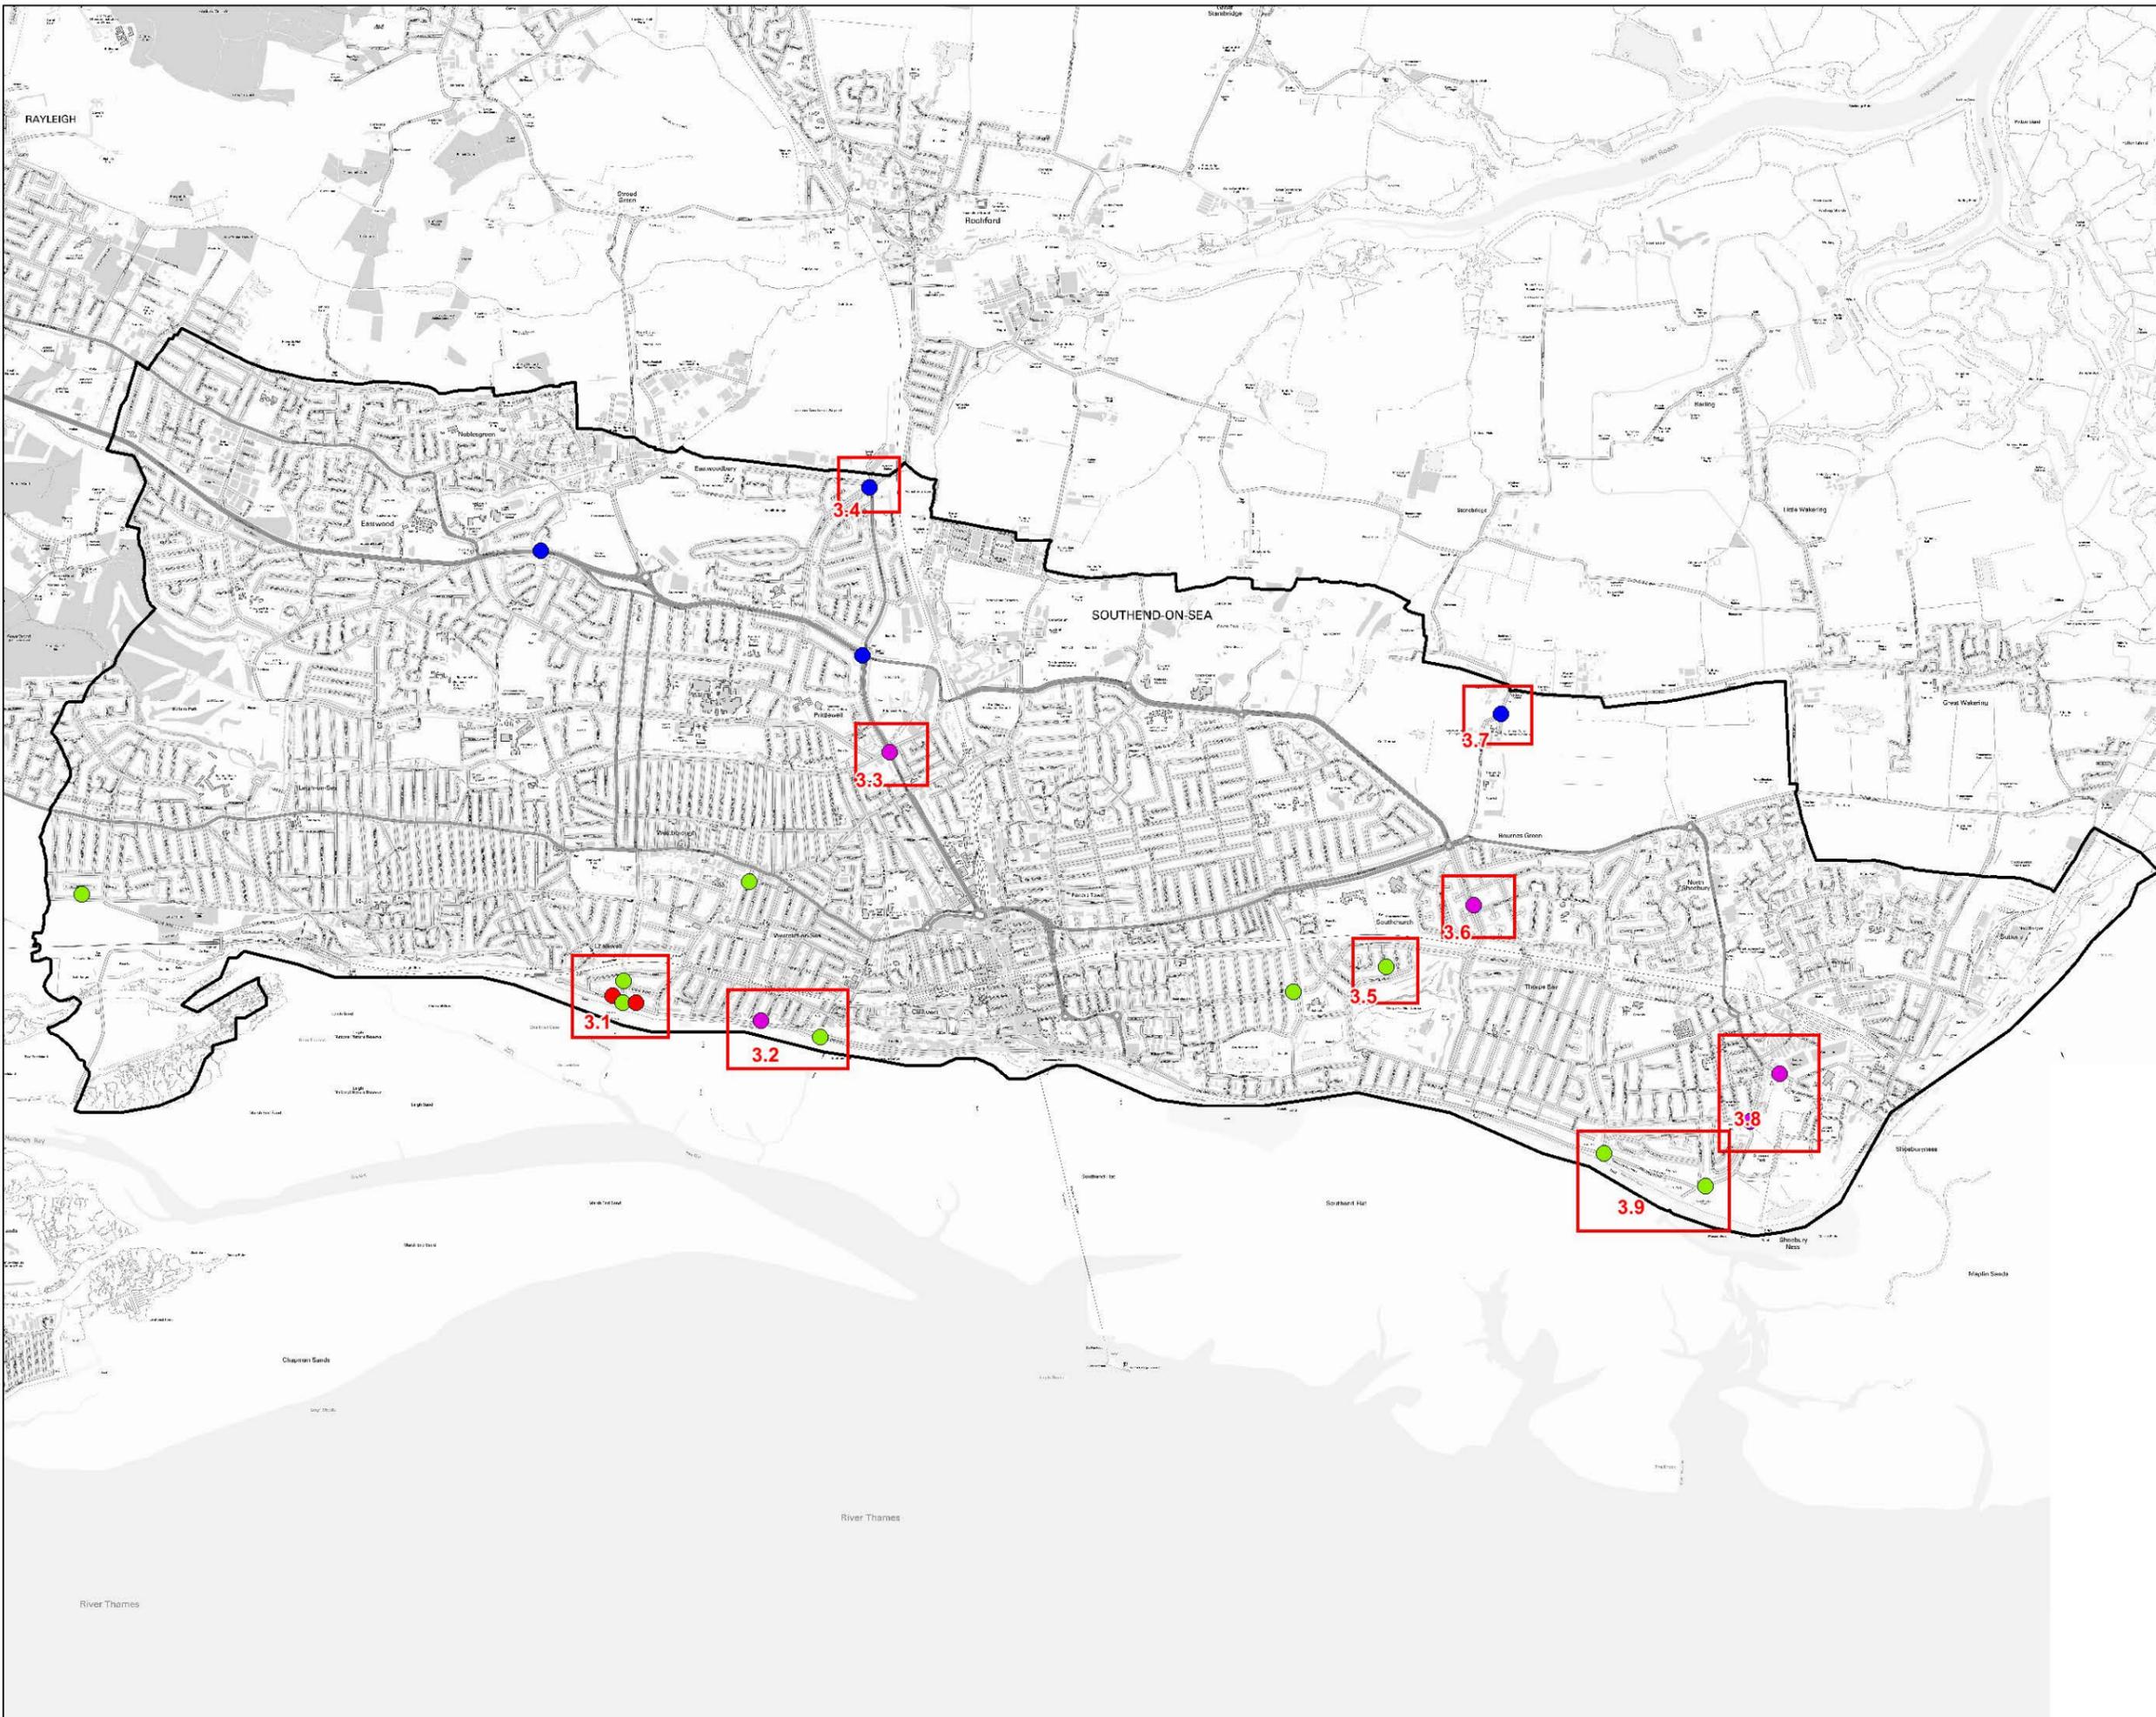
Drawing Number <b>Figure 2-4</b>	Rev <b>3</b>
-------------------------------------	-----------------

Figure 2-4 shows the location of flood records across Southend-on-Sea. It can be seen that there is a wide spatial distribution of the flooding incidents recorded on the 11<sup>th</sup> October. In total 20 incidents of flooding were recorded on the 11<sup>th</sup> October. Of these:

Following the 11<sup>th</sup> October event, three areas were recorded to flood again on the 13<sup>th</sup> October. Whilst the 13<sup>th</sup> October event alone would not warrant a formal Flood Investigation, as the event occurred within a short time of the 11<sup>th</sup> October event, it has been considered to be related. The locations of the incidents recorded on the 13<sup>th</sup> October are also shown in Figure 2-4.

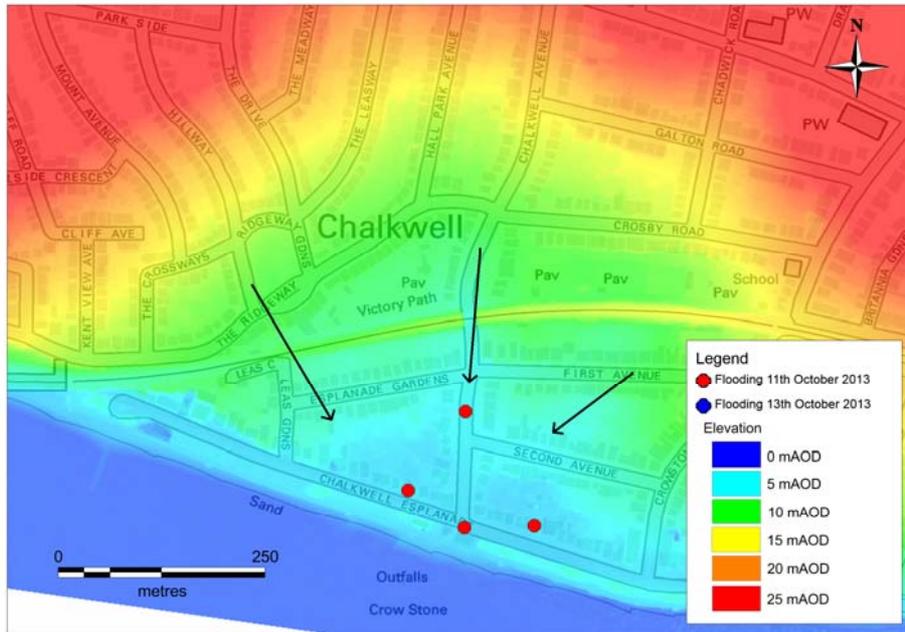
Figure 3-1: Topography of Chalkwell area (black arrows indicate the general overland flow route)  
 Contains Ordnance Survey data © Crown copyright and database right 2014

The southern extent of Chalkwell Avenue is relatively flat (Photograph 3-2) following the steep drop from the road to the north. If surface water is unable to enter the road gullies, water would follow the path of the road and accumulate within the area to the south. It should be noted that due to the time of year, road gullies may have been partially blocked by leaf litter, reducing their drainage efficiency.

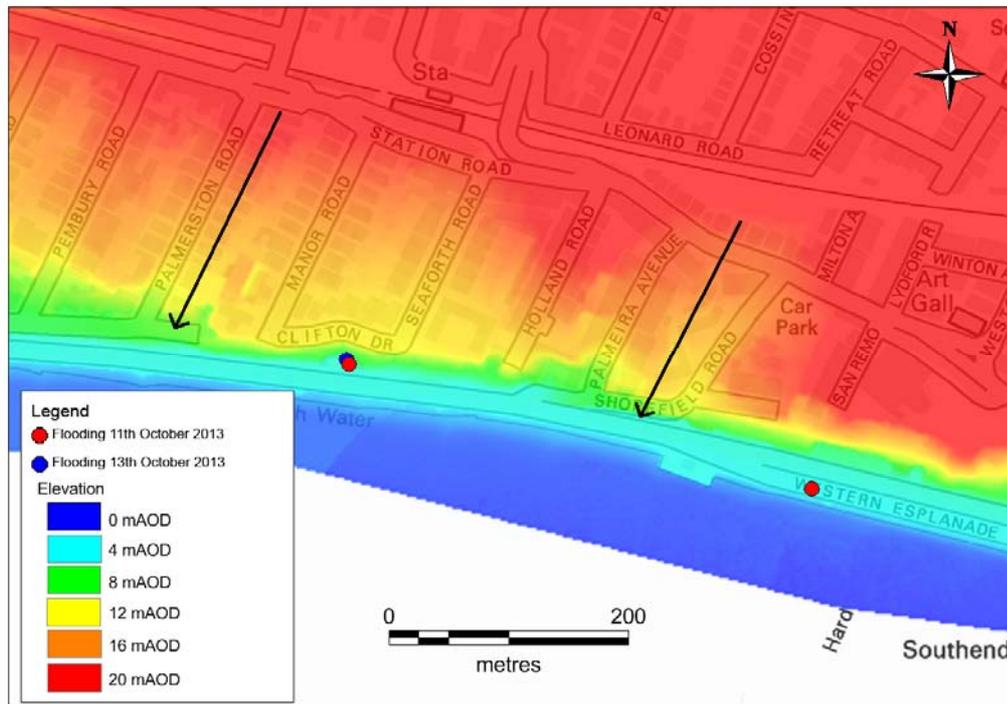
Figure 3-2: Topography of Clifton Drive (black arrows indicate the general overland flow route)  
 Contains Ordnance Survey data © Crown copyright and database right 2014

There is a considerable drop in elevation from Clifton drive to the Western Esplanade and the sea front (from 12.5 mAOD to 4.5 mAOD) as shown in Figure 3-2.

Due to the high tides, it is likely that the capacity of the network was further reduced by tide locking of the outfall. Water would therefore not have been able to discharge freely from the network. As the drainage area is heavily urbanised, runoff would be rapid. The capacity of the network would therefore reach capacity shortly after the rainfall. Photographs 3-3 to 3-6 were taken at approximately 16:50, 50 minutes after the peak rainfall was recorded and at the time of the high tide.

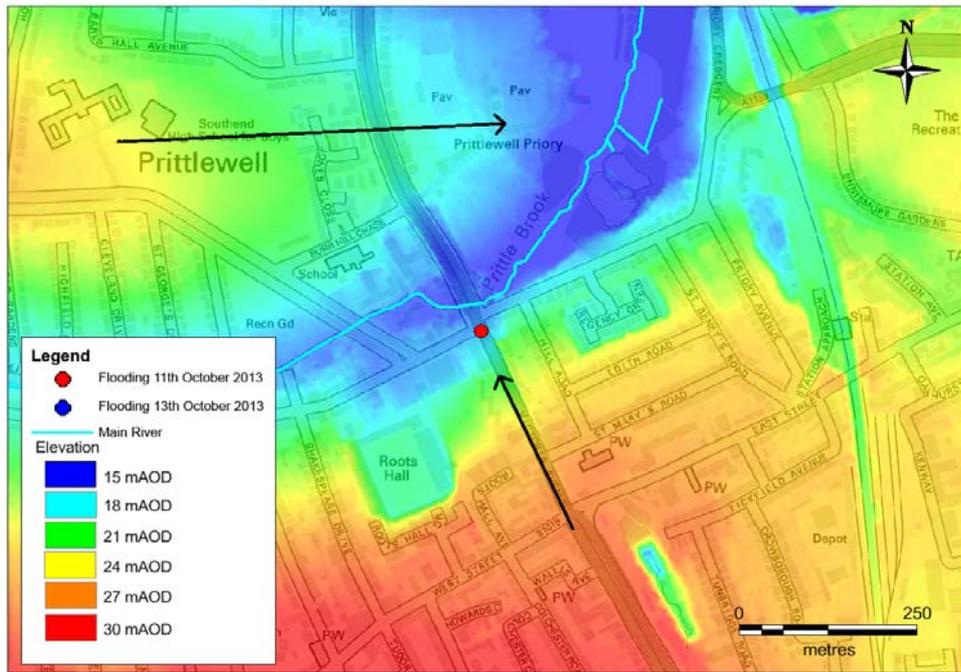
Figure 3-3: Topography of Victoria Avenue (black arrows indicate the general overland flow route)  
 Contains Ordnance Survey data © Crown copyright and database right 2014

There is a dip in the elevation of Victoria Avenue just to the north of the junction of Priory Crescent and Fairfax Drive as shown in Figure 3-3. Just beyond this point, Victoria Avenue crosses the channel of Prittle Brook. Prittle Brook is culverted for a short section underneath the road and flows in a north easterly direction towards Prittlewell Priory.

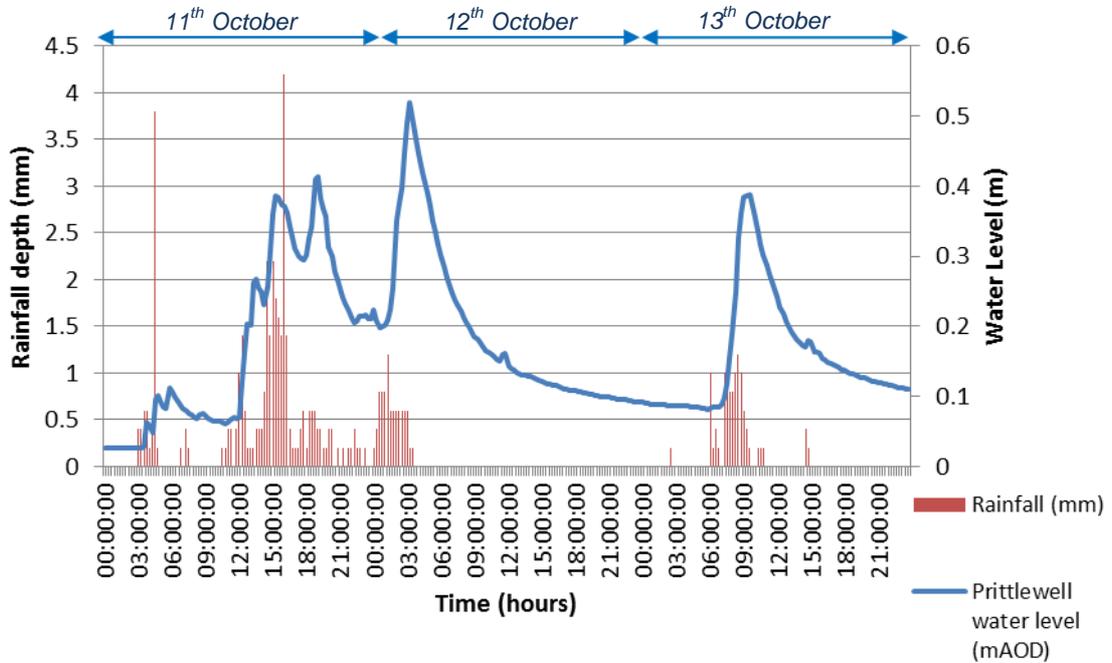
Figure 3-4: Recorded Prittle Brook water levels (at Prittlewell) and rainfall (at Southchurch Park) - from 00:00 11/10/13 to 23:34 13/10/13

The water levels of the Prittle Brook respond rapidly to rainfall as can be seen in Figure 3-4. In this instance, there are two peaks in the river levels on the 11<sup>th</sup> October in response to the rainfall. This would have been likely to rise above the outfall level of the surface water sewers.

Brook exceed the channel capacity, there is the potential for water to back-up through the surface water outfalls.

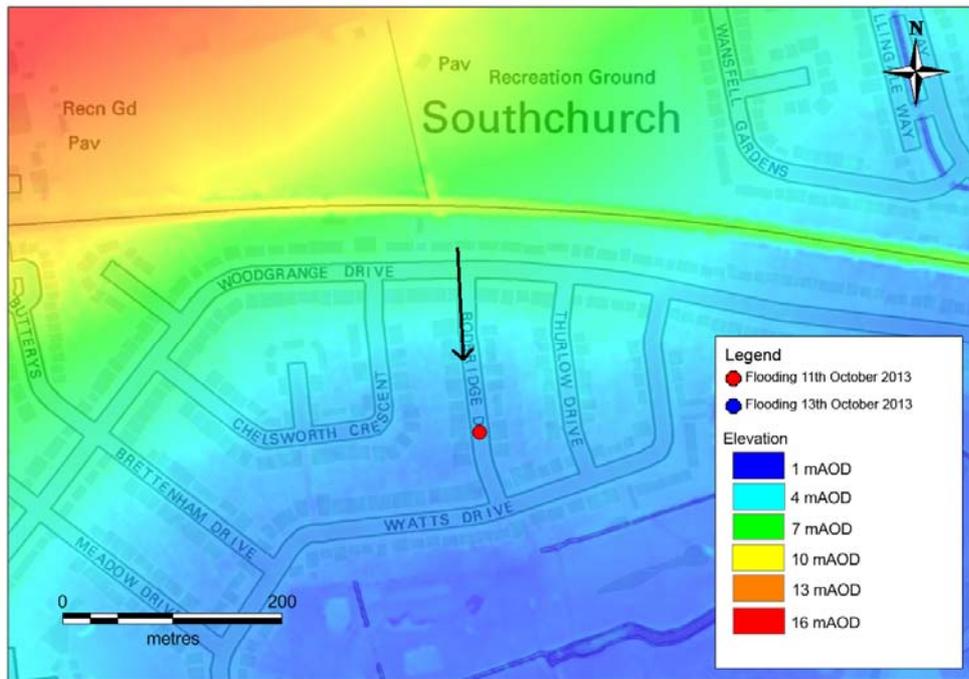
Figure 3-6: Topography of Rodbridge Drive (black arrows indicate the general overland flow route)  
Contains Ordnance Survey data © Crown copyright and database right 2014

Due to the topography, surface water runoff from the north would be likely to flow along the road towards Wyatts Drive in the south.

Observations from the site walkover on the 28<sup>th</sup> August 2014 showed there to be a number of road gullies on both sides of the road. Should these be blocked or obstructed, surface water would tend to accumulate within the channel of the road.

The mechanisms for flooding at Rodbridge Drive could not be determined from the data available. It has therefore been recommended that the Anglian Water and Southend-on-Sea Borough Council undertake surveys of the drainage network in this area to determine the cause of the flooding and improve understanding of the flooding mechanisms.

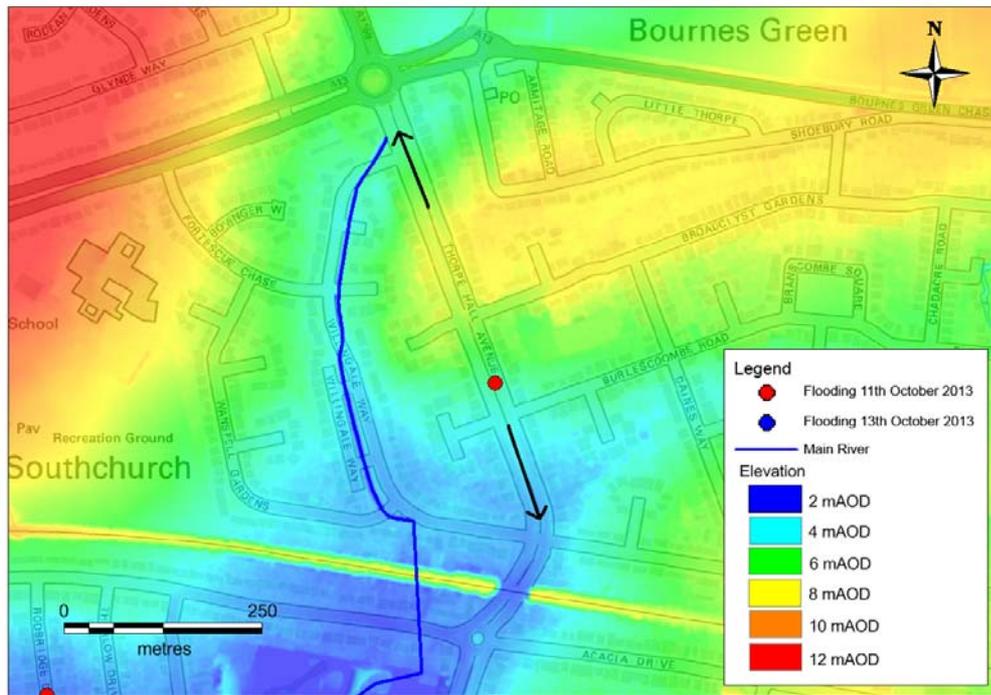
Figure 3-7: Topography of Thorpe Hall Avenue (black arrows indicate the general overland flow route)  
 Contains Ordnance Survey data © Crown copyright and database right 2014

As shown in Figure 3-7, the elevation of Thorpe Hall Avenue declines in both a northerly and southerly direction. Water overflowing from the manhole would follow the path of Thorpe Hall Avenue to the south, towards Acacia Drive.

Discussions with AW have indicated that in this instance, the manhole cover within Thorpe Hall Avenue, associated with the surface water network, had not been bolted down following inspections completed prior to the event. Therefore, the higher flows within the network as a result of the rainfall would have caused water to surcharge and lift the cover.

It is likely, that should the cover had been secured, there would not have been flooding within the carriageway.

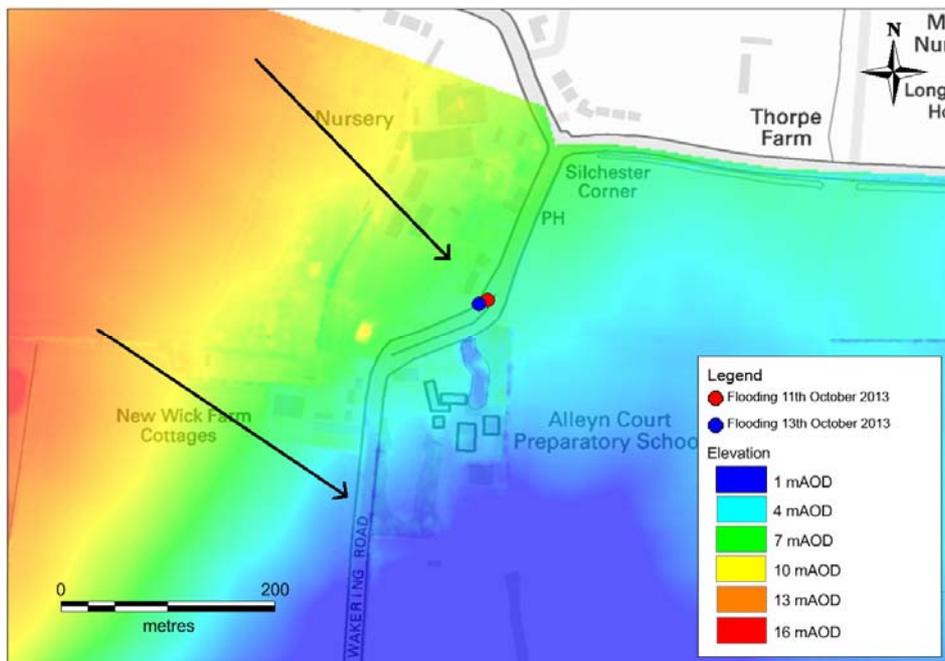
Figure 3-8: Topography of Waking Road (black arrows indicate the general overland flow route) Contains Ordnance Survey data © Crown copyright and database right 2014

There are numerous road gullies located along the road in both directions.

On becoming aware of the flooding, SBC contractors attended the site and determined the cause of flooding to be due to lack of capacity created by the collapsed gully connection. Measures were taken by SBC to clear the network and replace the broken section of pipe.

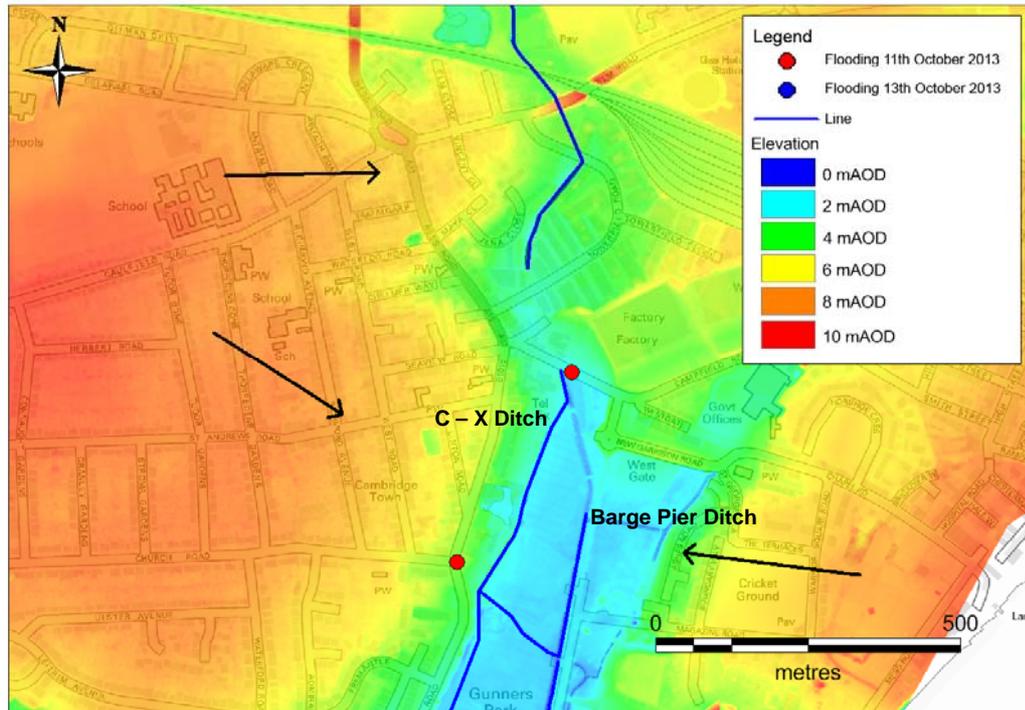
Figure 3-9: Topography around Campfield Road and Ness Road (black arrows indicate the general overland flow route) Contains Ordnance Survey data © Crown copyright and database right 2014

It is considered likely, that there would be high water levels within the C-X Ditch at the time of the flooding incidents as the outfall to the Estuary would have been tide-locked around the time of the peak rainfall. In addition, it was reported that there was extensive vegetation growth within the river channel at the time. Therefore, the capacity of the channel downstream of the culvert may have been reduced.

In both instances, the surface water networks discharge to the ditches within Gunners Park. As a result of the impeded outfalls and high water levels in the drainage ditch, surface water discharge may have been restricted resulting in water backing up within the networks.

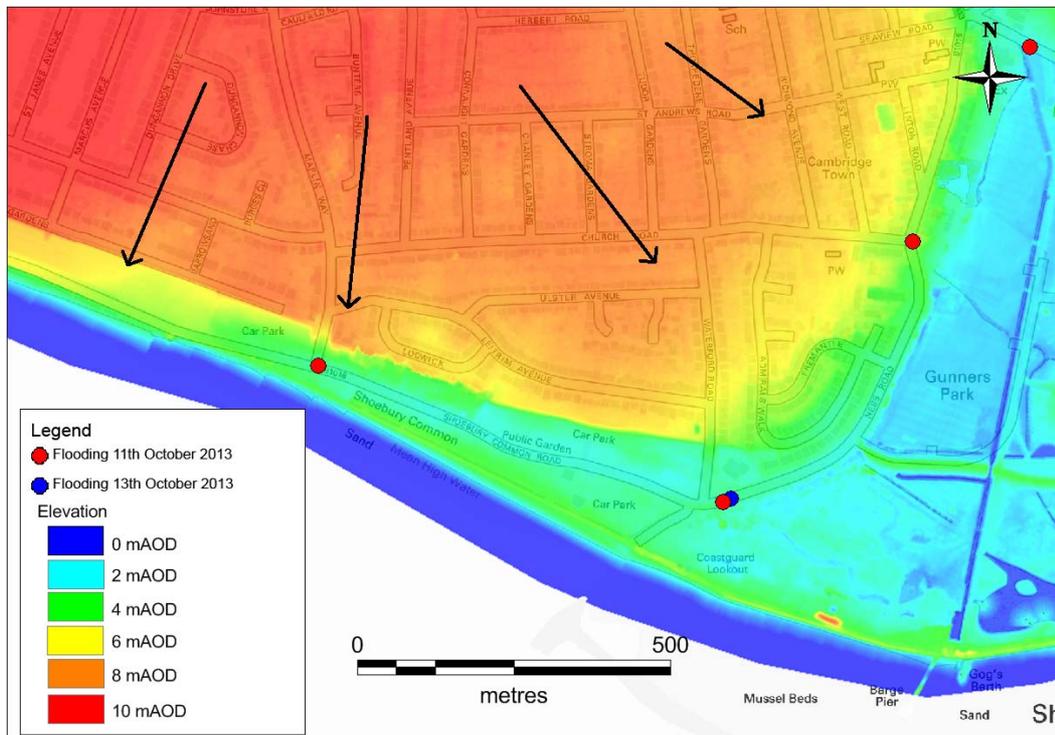
Figure 3-10: Topography of Ness Road and Shoebury Common Road (black arrows indicate the general overland flow route)  
 Contains Ordnance Survey data © Crown copyright and database right 2014

Ness Road is located to the west of Gunners Park. Shoebury Common Road runs to the north, parallel to Shoebury Common. Both roads are at a low elevation in relation to the surrounding area, with a level of approximately 2.5m AOD (Figure 3-10).

Flooding at the junction of Maplin Way is reported to have occurred as a result of the failure of the tidal flap valve allowing sea water ingress up the network as the tidal levels increased. This would have resulted in flooding from the restriction of the outflow and the reduced capacity of the network. Water would therefore have surcharged from the network through gullies and manholes as the water level at the end of the network increased.

High level hydraulic calculations undertaken using MicroDrainage WinDES software, show that the Ness Road surface water network would not flood providing there is free discharge from the outfall. A 50% reduction in the outfall capacity would however result in flooding of the network following 0.93 mm of rain, 16 minutes following the onset of rain. Further details are provided in Appendix B.

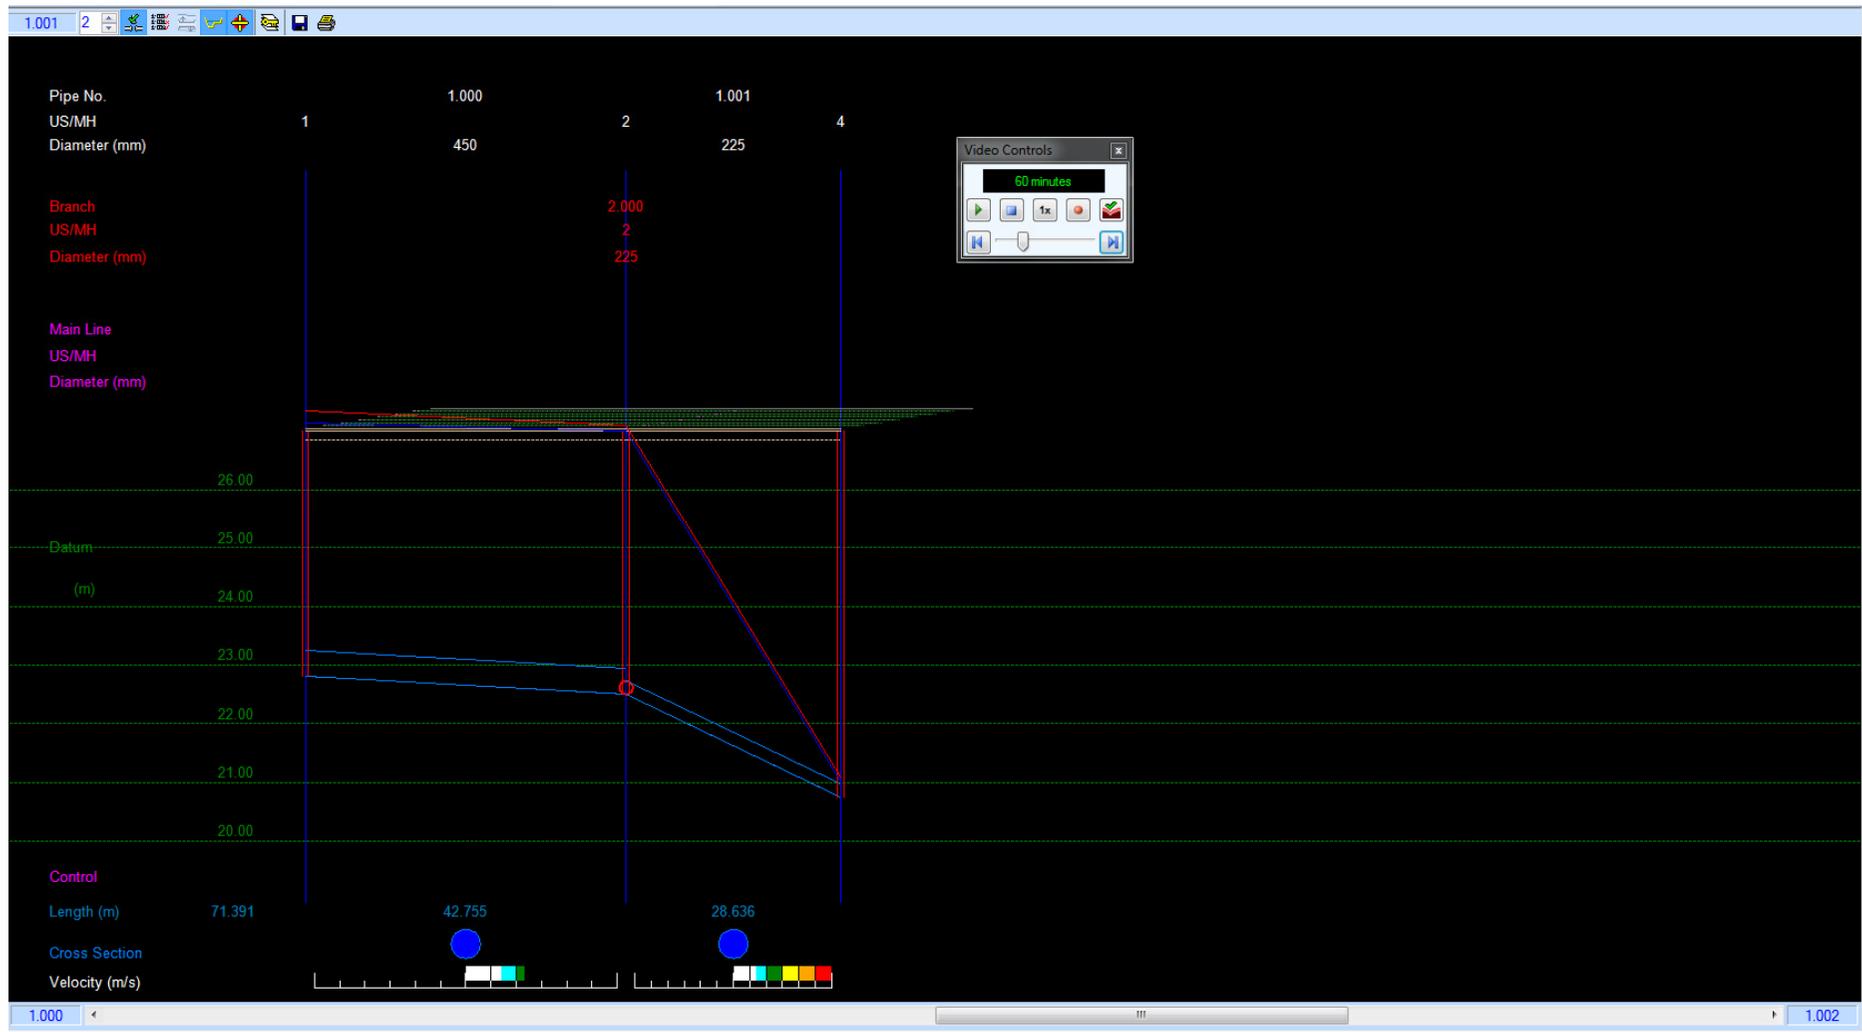
(iii) 0% tide locked scenario

(iii) For the 0% discharge reduced tide locked scenario, flooding would occur around 60 mins after the onset of rain. So flooding requires **9.90 mm of rain**

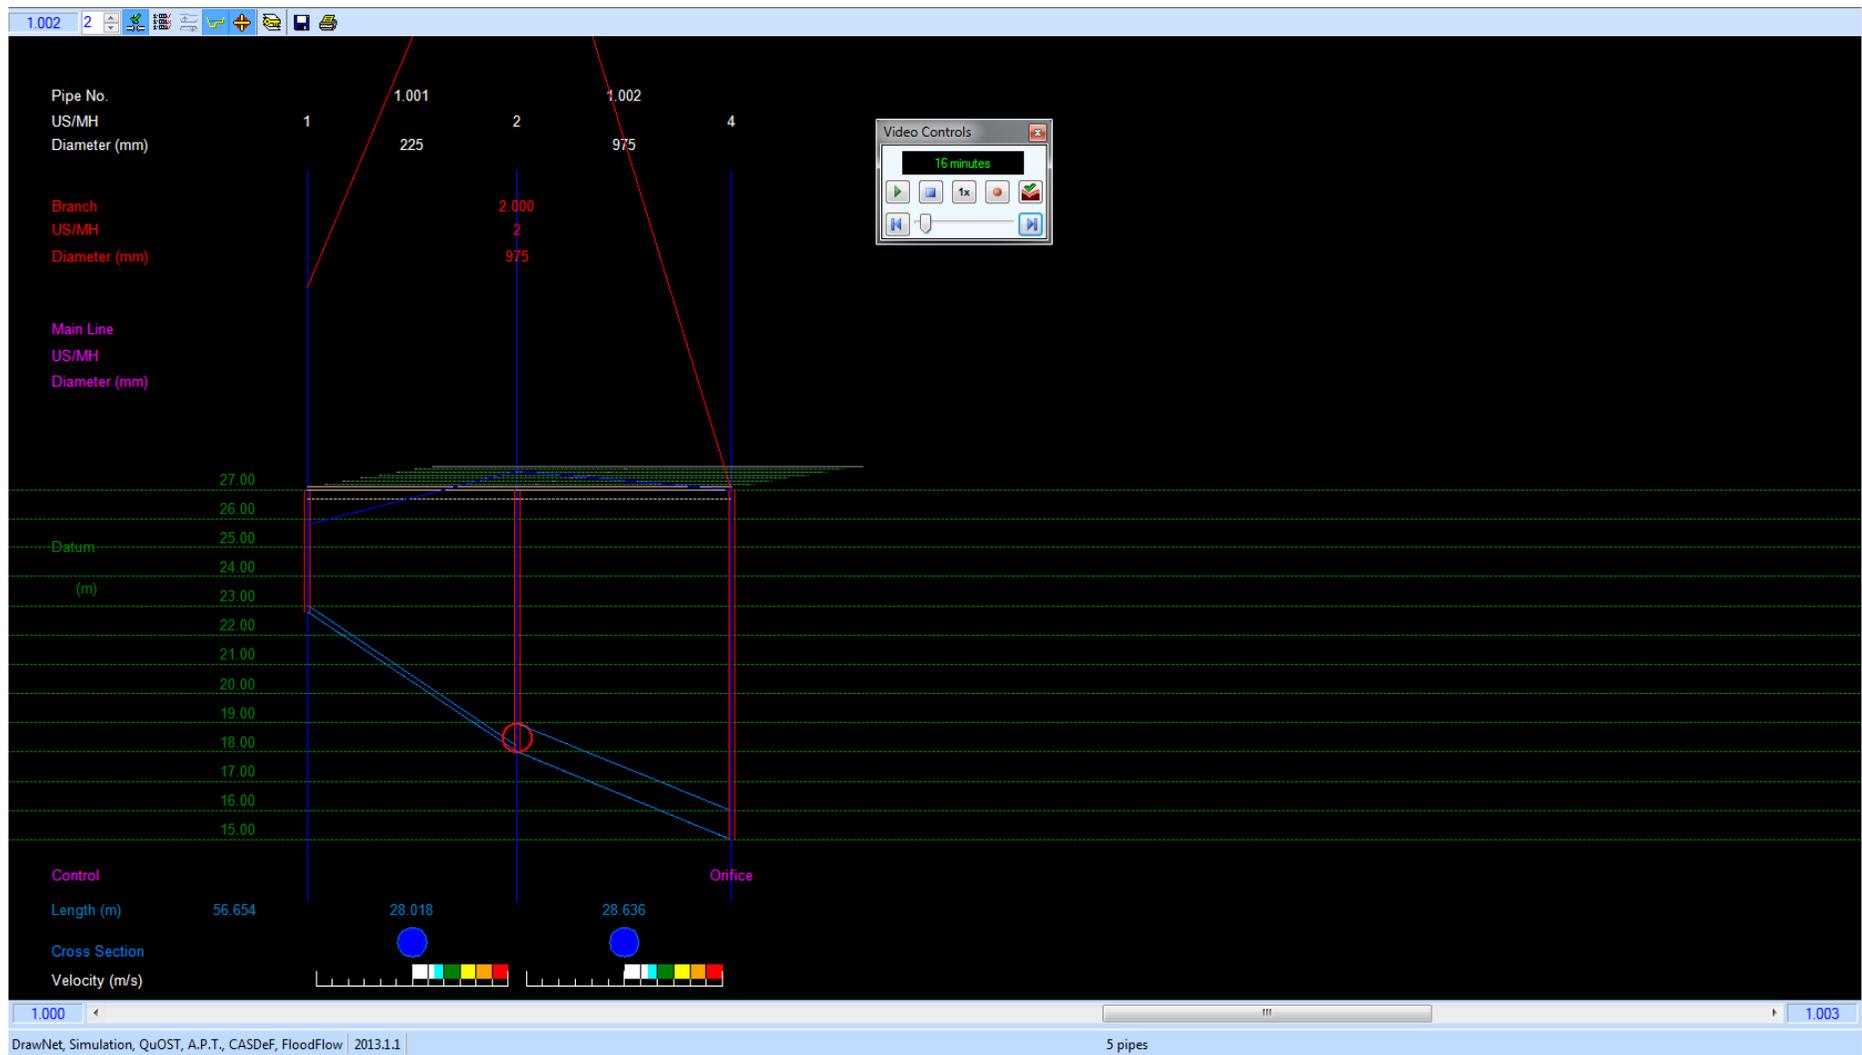
(ii) 50% tide locked scenario

(ii) For the 50% discharge reduced tide locked scenario, flooding would occur around 16 mins after the onset of rain. So flooding requires **0.93 mm of rain**

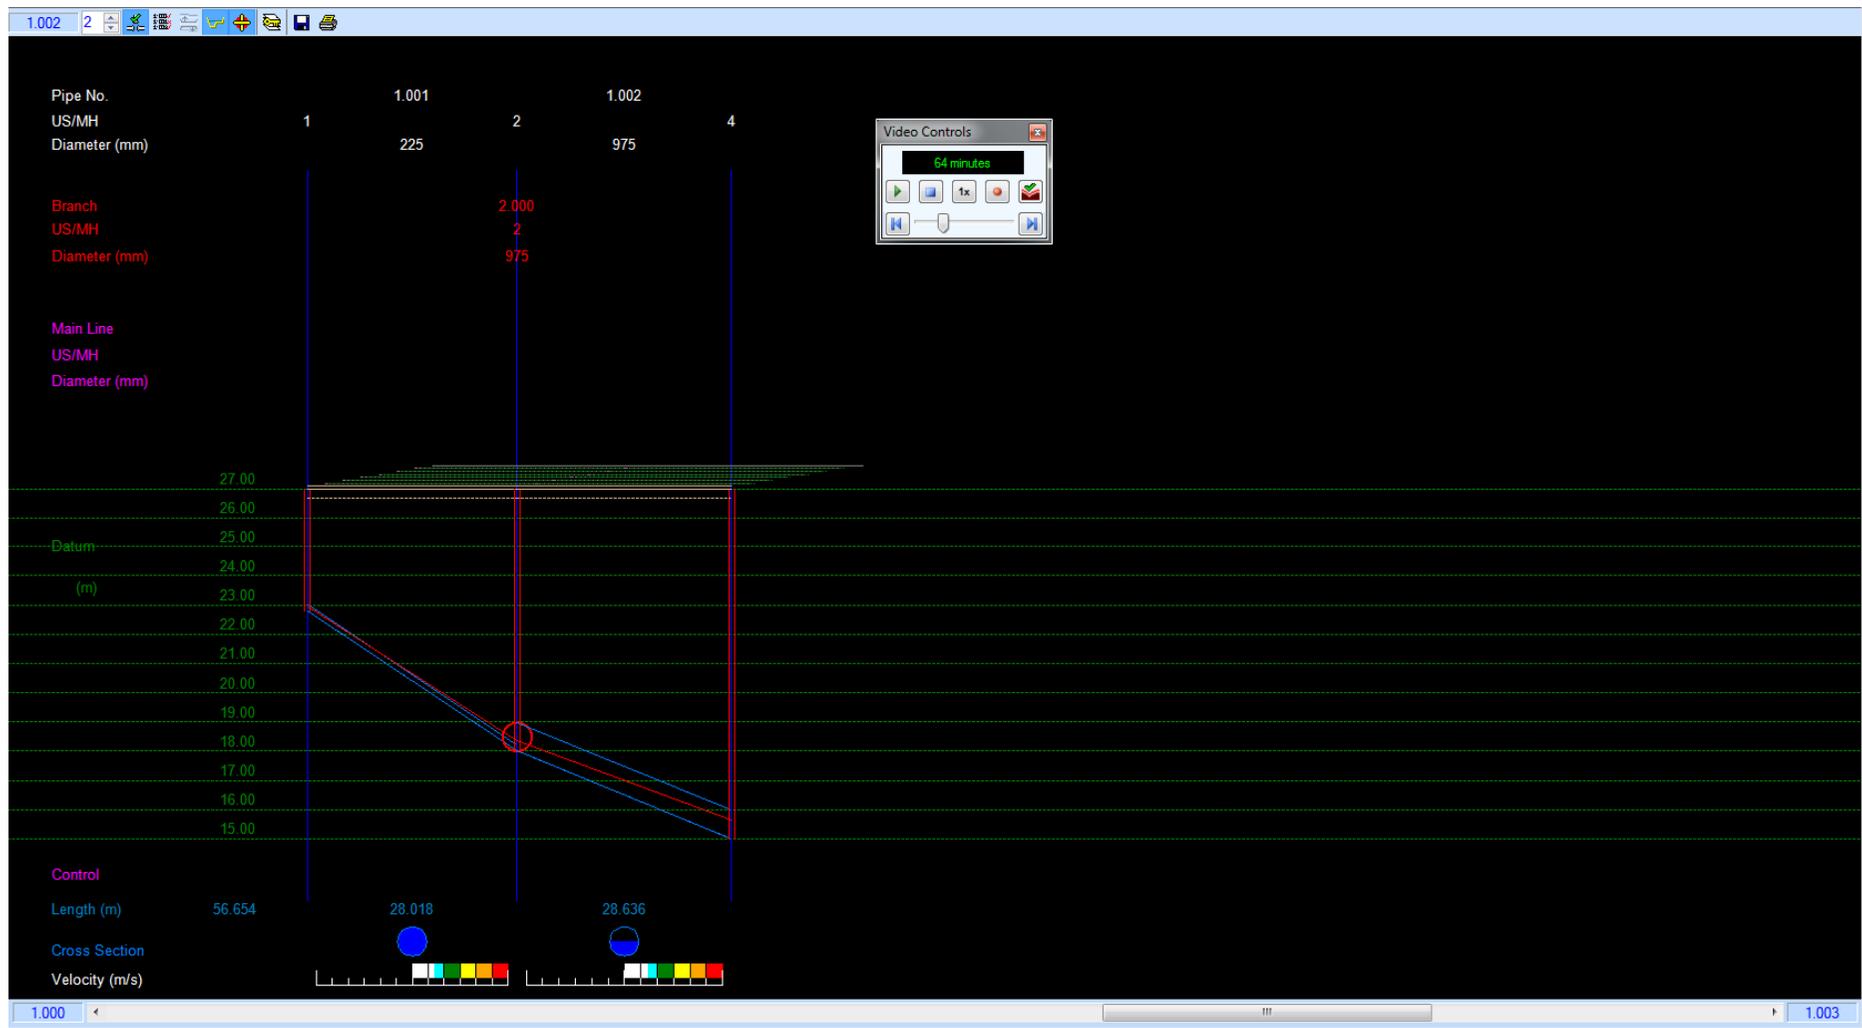
(iii) 0% tide locked scenario

(iii) For the 0% discharge reduced tide locked scenario, flooding would not occur
