Southend-on-Sea Borough
Council

Submitted by
AECOM
Scott House, Alencon
Link, Basingstoke,
Hampshire RG21 7PP

Southend-on-Sea 19th September 2014 Flood Investigation Report

November 2015

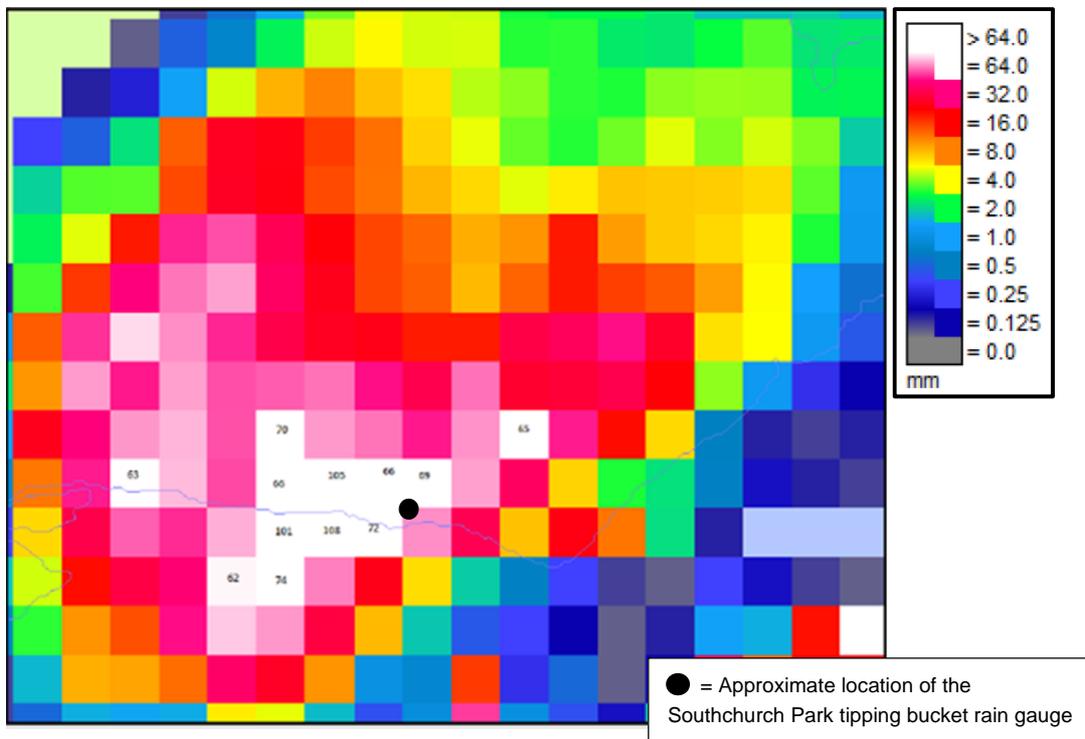
Figure 2-1: Environment Agency Radar Imagery - Cumulative Rainfall from 20:00 - 21:00

Data from the Met Office Thurnham Rainfall Radar Station (1km resolution) estimated a 24 hour rainfall total of 72.2mm and a two hour total of 71.4mm from 19:00 to 21:00 on the 19th September 2014. According to this data set, at the peak rainfall intensity, 41.7mm fell over a 30 minute period between 20:25-20:55. Radar imagery shown in Figure 2-1 below, provided by the Environment Agency, shows the area experiencing the highest rainfall intensity to be located across the central seafront area within Southend-on-Sea.

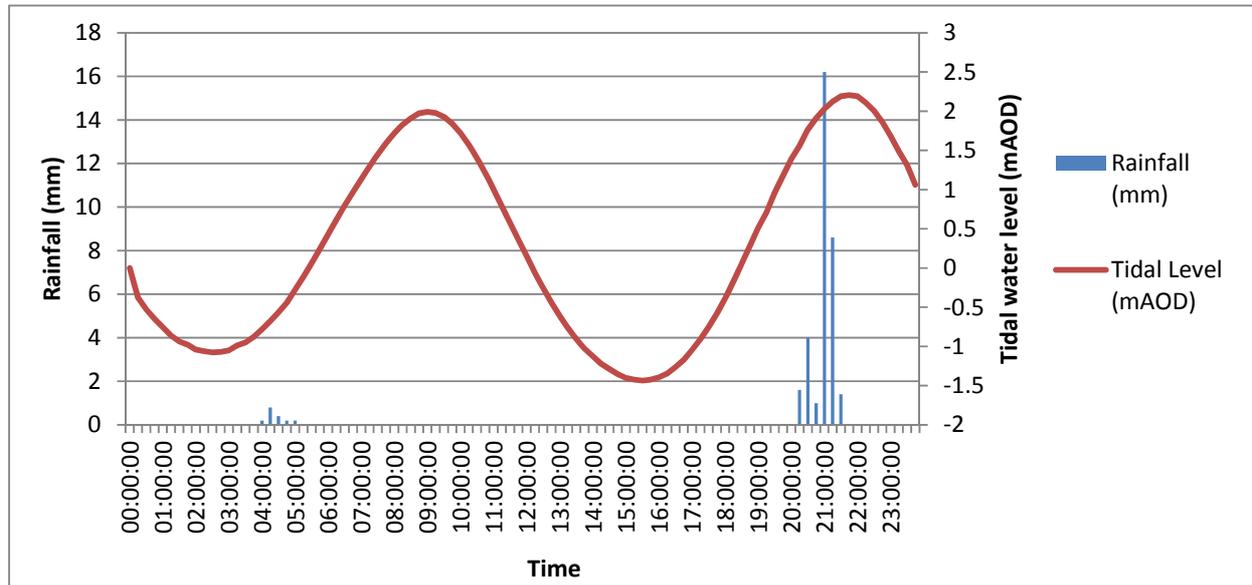
Figure 2-2: Recorded rainfall at Southchurch Park and tidal levels and Southend Pier on the 19th September 2014

Some of the flood incidents were recorded along the seafront area and could potentially be affected by tide levels at the time of the high intensity rainfall. Figure 2-2 details the tidal water levels recorded at Southend Pier. It can be seen that the high tide occurred shortly after the peak rainfall, reaching a level of 2.5m at 21:30.

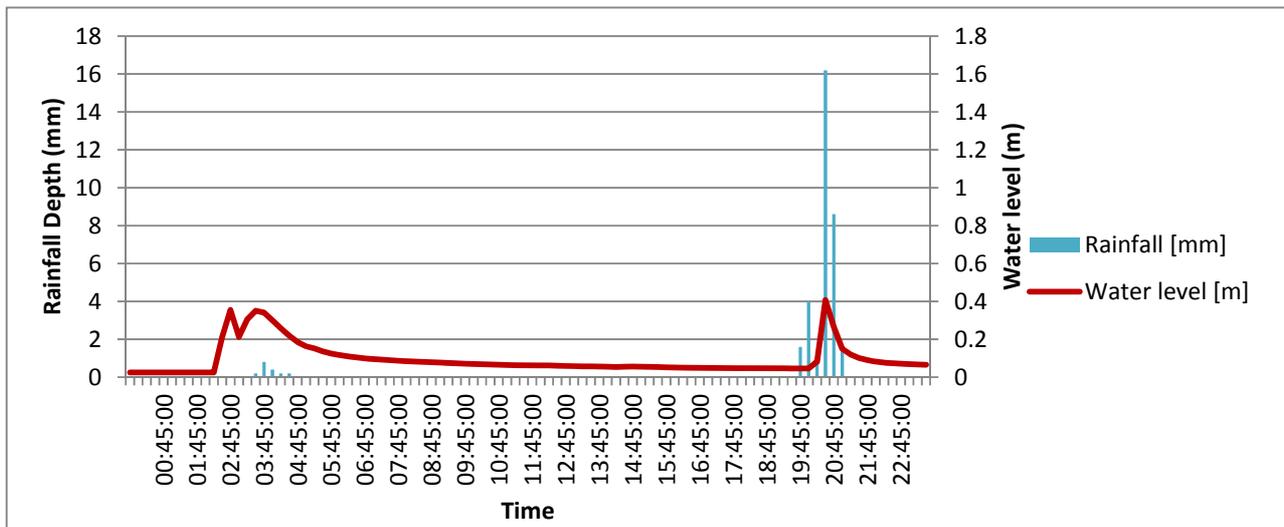
Figure 2-3: Recorded Rainfall at Southchurch Park and River Levels at Belfairs Park on 19th September 2014

Water levels of the Prittle Brook are recorded by the Environment Agency at a gauging station within Belfairs Park (NGR: 583292, 187035). Figure 2-3 shows the water levels of the Prittle Brook on the 19th September along with the recorded rainfall.

It should be noted that the Prittle Brook drains from Hadleigh in Castle Point, west through Southend-on-Sea, before flowing north towards the River Roach. As the focus of the storm occurred to the south and west of Southend-on-Sea, the resultant flows within the Prittle Brook through Southend-on-Sea are likely to have been influenced by the rainfall. Figure 2-3 shows a rapid but small response recorded at the Belfairs Park gauging station, following the rainfall event.

However, flow readings of the Prittle Brook (Figure 2-3) suggest that levels were not particularly high at the time of heavy rainfall on the 19th September 2014. While the river levels may not have impacted surface water drainage at the time of the storm, river levels did rise shortly after the storm which may have impacted the rate at which surface water could drain away. Residents in Vardon Drive report that it took at least an hour after the rain had subsided for surface water to recede.

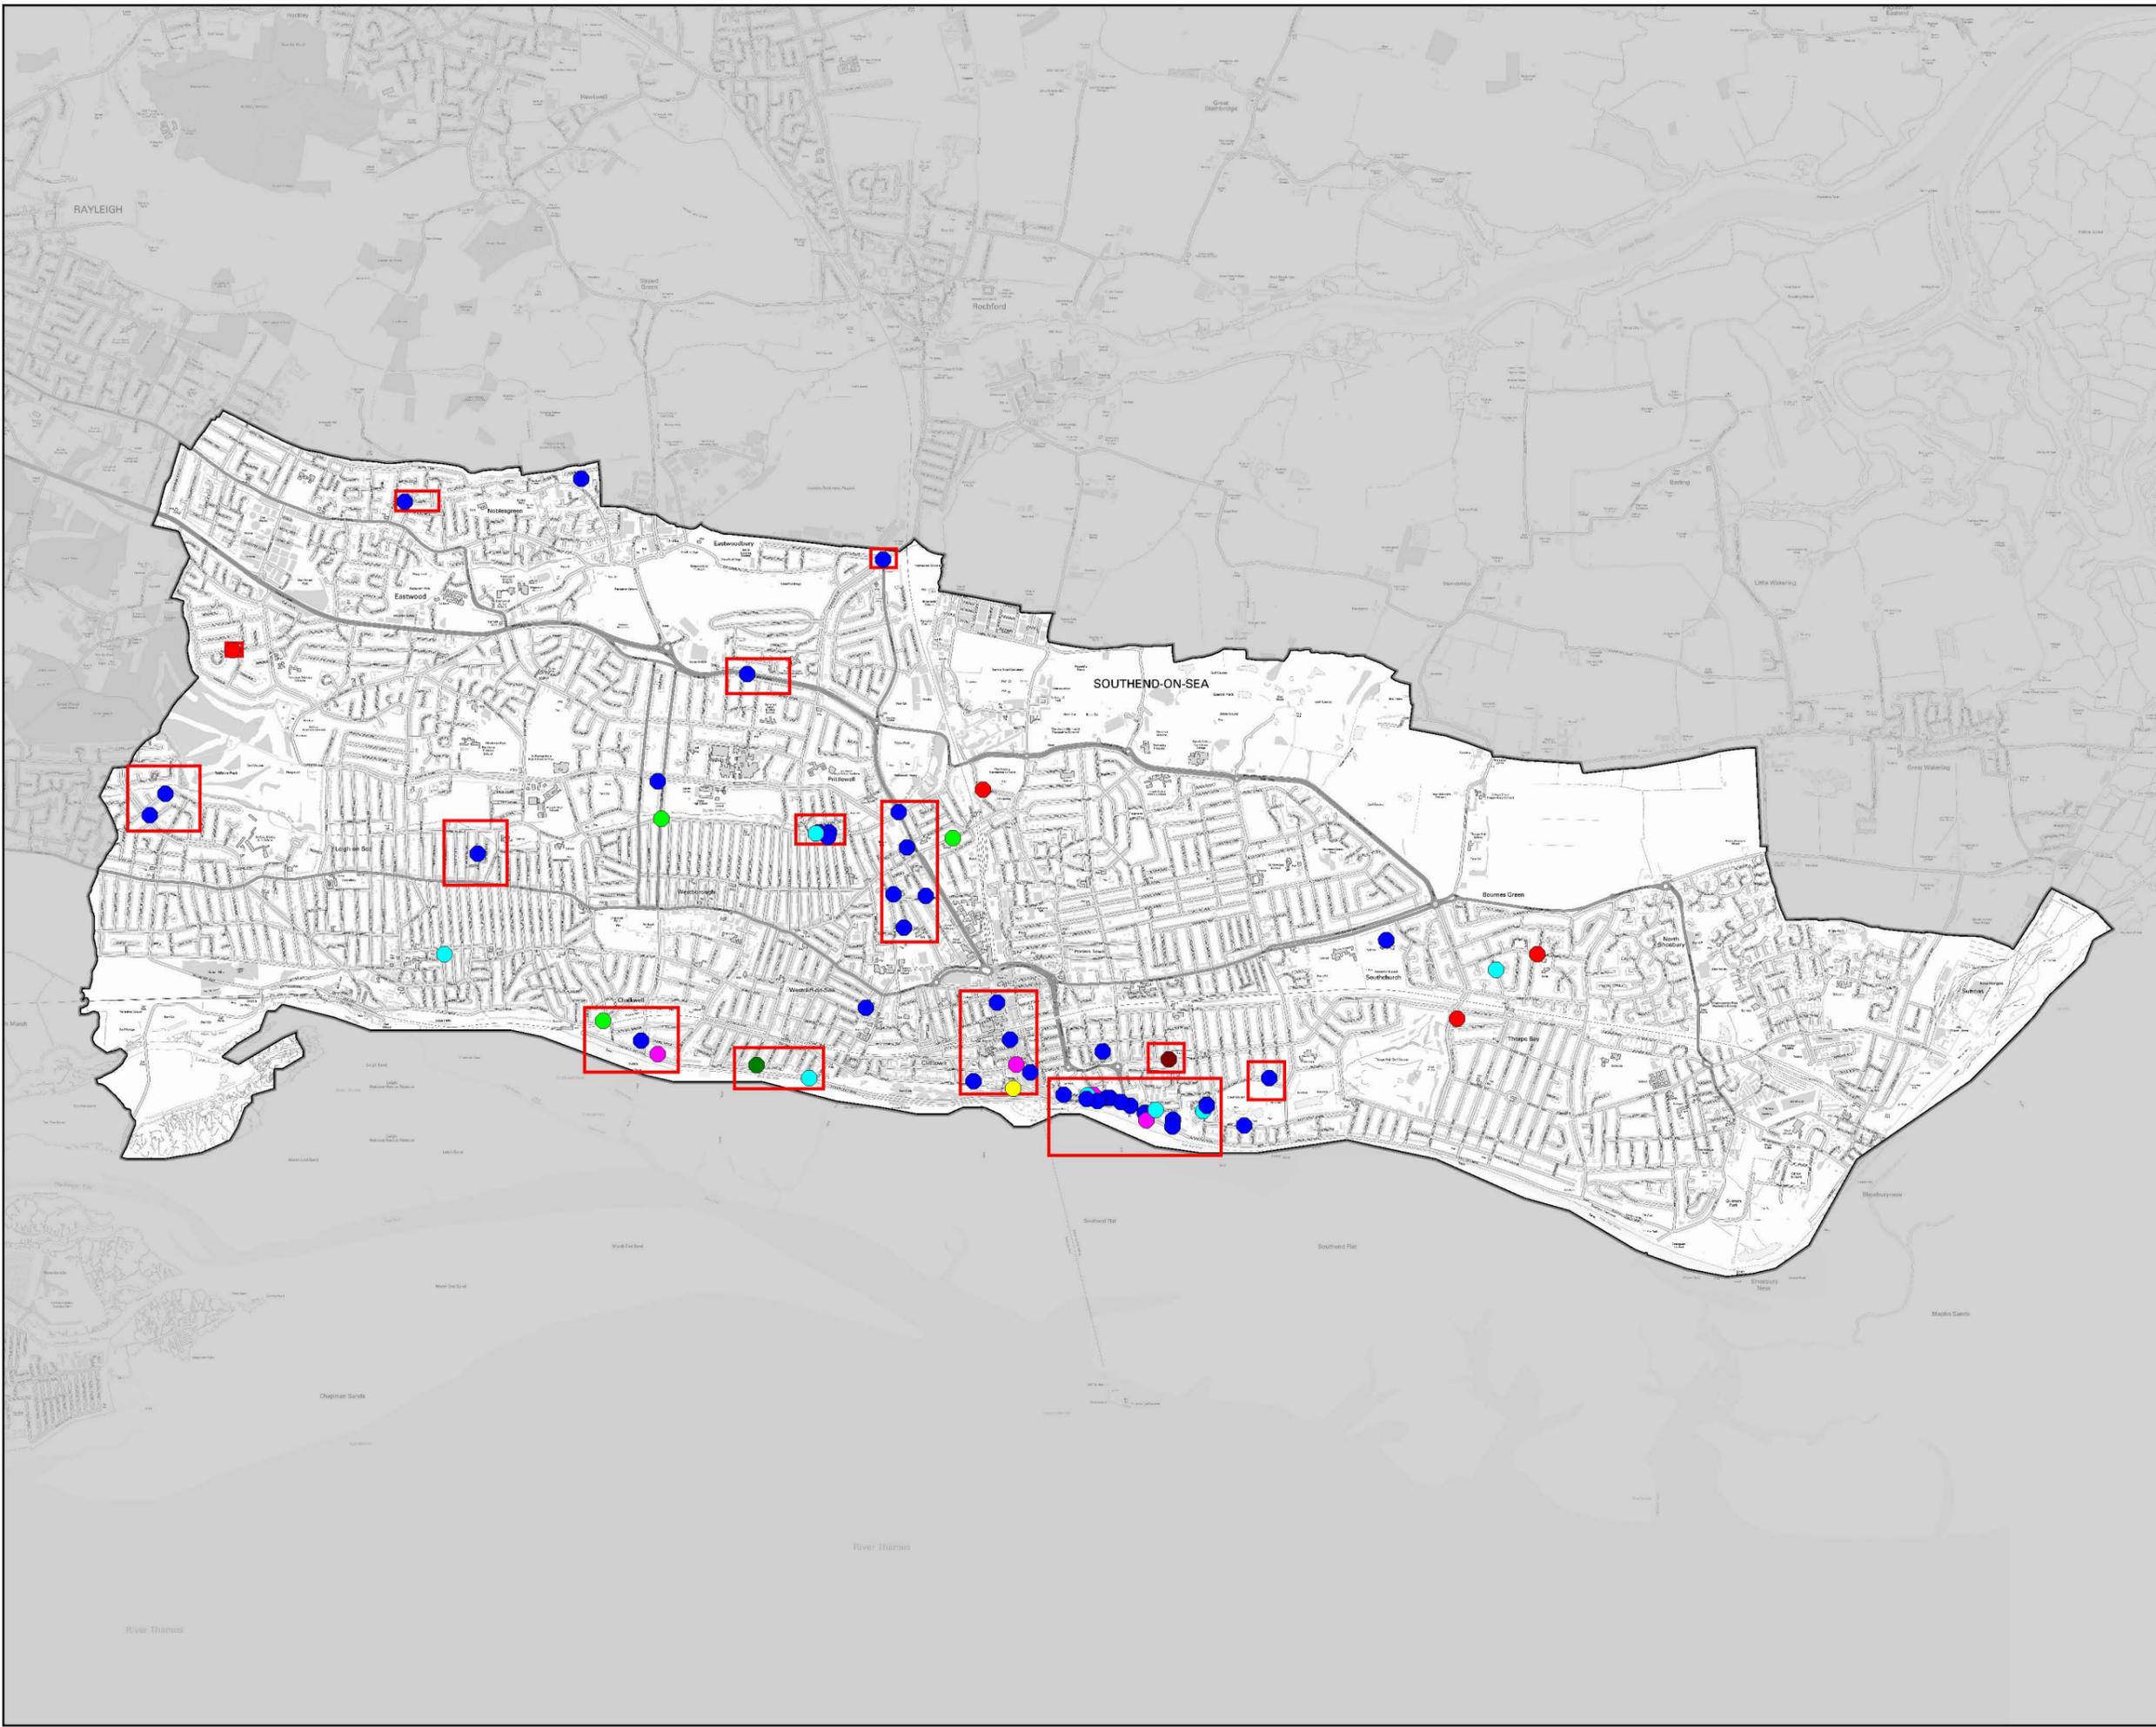
Drawing Number Figure 2-4	Rev 2
-------------------------------------	-----------------

Figure 2-4 shows the locations of recorded flooding across Southend-on-Sea. It can be seen that the distribution of flooding incidents is focused to the west and south of the borough.

- 1 record of sewer flooding;
- 1 record of ground movement as a result of flooding;
- 1 record of flooding wherein an emergency rescue was required;
- 4 records of flooding which required pumping;
- 4 records of flooding as a result of blocked gullies;
- 3 records of blown gullies and manhole covers;
- 1 record of sewage backing up;
- 7 records of 'other' flooding incidents including those relating to carriageway damage, debris and sewerage in the road; and,
- 41 instances of flooding from unspecified/combined sources.

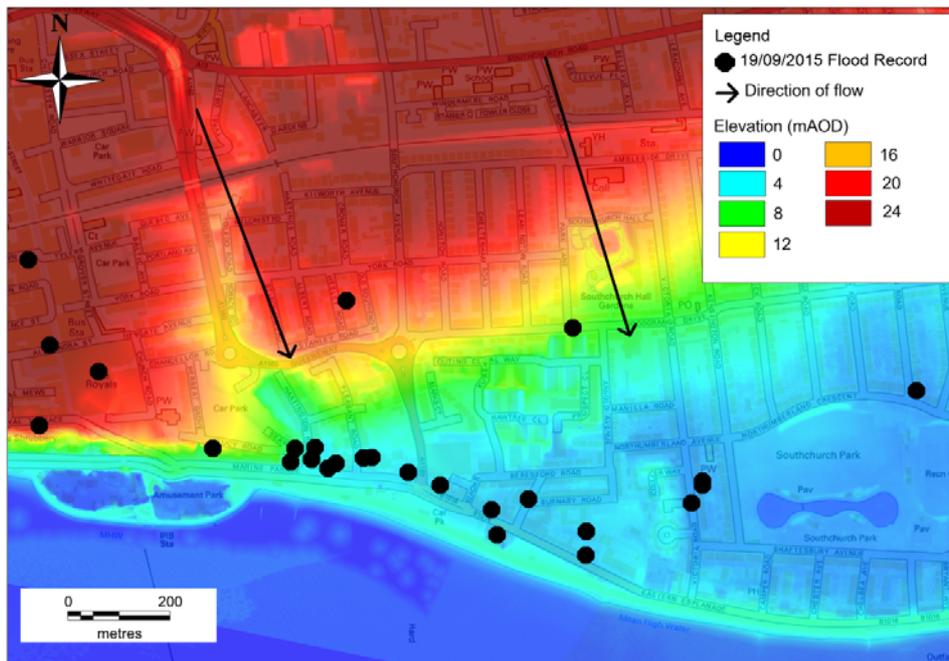
**Figure 3-1: Topography around Southend-on-Sea Central Seafront
Contains Ordnance Survey data © Crown copyright and database right 2015**

Eastern Esplanade and Marine Parade are located along the southern boundary of the borough in areas of low lying topography. As can be seen in Figure 3-1 to the north of Marine Parade, the ground rises steeply with an approximate gradient of 1:2.5. The rise of the land to the north of the Eastern Esplanade is, however, more gentle. A bank runs diagonally across the borough, north of Eastern Esplanade, from Queensway at Marine Parade to Bourne Green with a slope of approximately 1:25.

Victoria Road is located at a low elevation of approximately 2-3 mAOD and is susceptible to the accumulation of surface water runoff within the road channel. Frequently, this has resulted in water flooding properties on the eastern side of Victoria Road, 2 of which reported flooding on the 19th September 2014.

It is recommended that the maintenance regime for gullies (SBC highways) and the surface water drainage network (Anglian Water) is examined and updated as necessary to include more frequent cleansing in areas that are susceptible to flooding within the central seafront area.

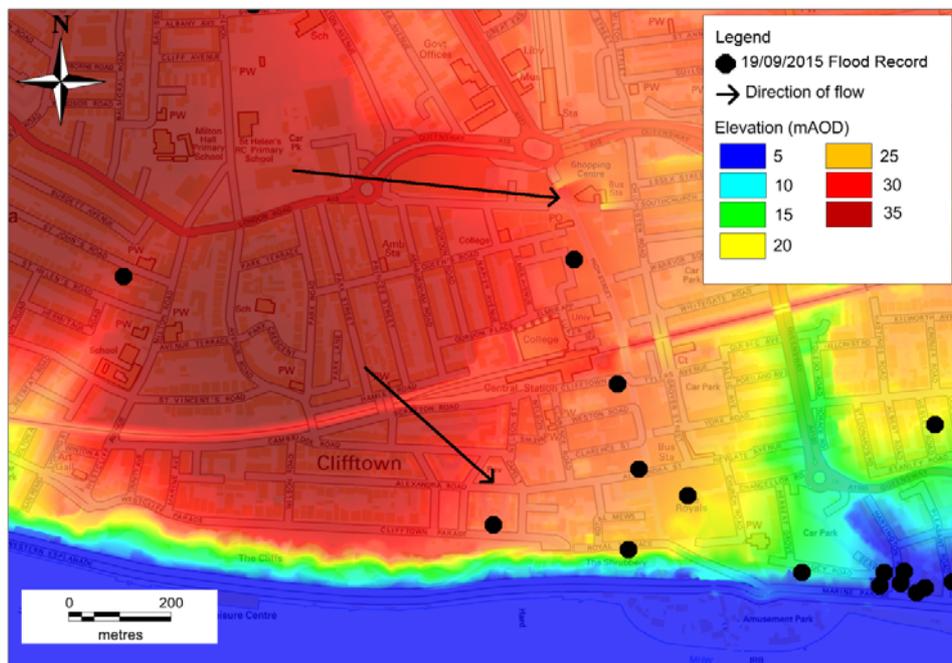
**Figure 3-2: Topography around the High Street area towards seafront
Contains Ordnance Survey data © Crown copyright and database right 2014**

The northern extent of the High Street and the surroundings areas are located at a relatively high topographic level of 30-35 mAOD. To the south of the study area there are steep slopes falling from approximately 30 mAOD at Clifftown Parade to approximately 10-5 mAOD at Royal Terrace and Lucy Road as shown in Figure 3-2.

The area of the High Street itself is relatively flat (Photograph 3-3) except for a dip below the railway line. Observations of the gullies and kerb drainage were made during the site walkover. No obvious blockages or constraints were observed other than a small downward dip on Clifftown Parade, which could encourage ponding. Within the pedestrianized area, kerbs were not present, resulting in a flatter surface to assist with access. This results in fewer obstructions to surface water runoff where adjoining roads meet the High Street. With no significant topographical influence, it is likely that flooding around the High Street was due to the high intensity of rainfall, exceeding the drainage capacity of the sewer network.

As with the seafront area, reports from a property owner on Clifftown Parade have attributed the flooding to the sheer volume of water that fell in a short period, which was not able to drain away quickly enough. It is likely that the rainfall was so intense that it simply exceeded the drainage capacity of the local surface water drainage network.

It is recommended that inspections of the drainage gullies and the surface water sewers are carried out in the areas which flooded to ensure they are operational and in good condition.

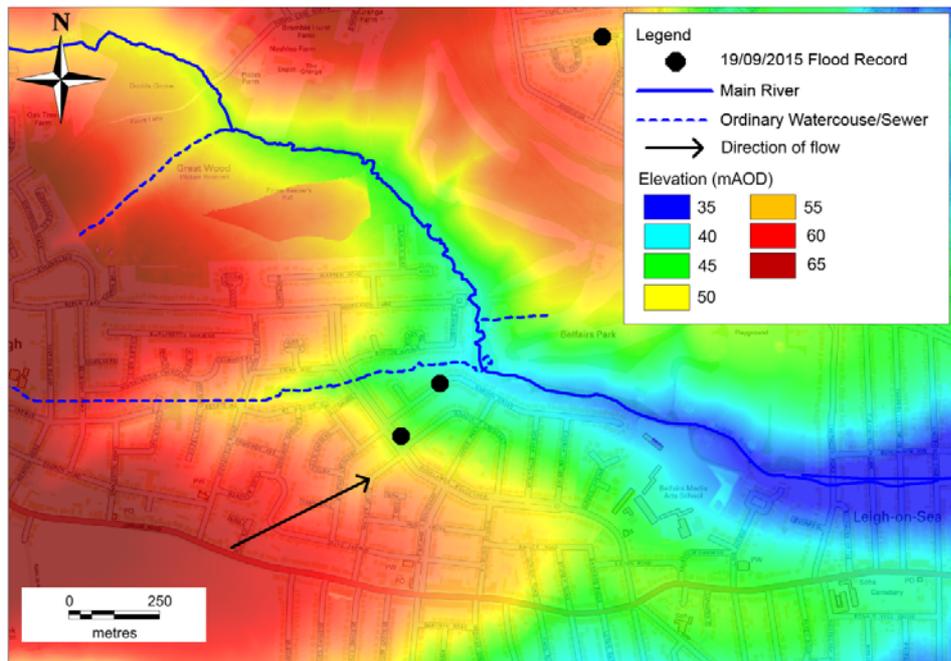
**Figure 3-3: Topography of Highland Boulevard and Vardon Drive
Contains Ordnance Survey data © Crown copyright and database right 2014**

As shown in Figure 3-3, Highlands Boulevard slopes in a northerly direction towards a tributary of Prittle Brook. There is a dip in local elevation as Highlands Boulevard turns to the north, where flooding was once more observed as it has been in previous incidents. Vardon Drive continues to slope downwards from Highlands Boulevard towards Prittle Brook. Incidents were recorded at the lowest parts of the street on 19th September 2014.

During the site walkover and from previous investigations, it has been observed that there is a considerable slope across the width of Highlands Boulevard, continuing along Vardon Drive. This suggests that the natural flow of surface water is towards Vardon Drive which has very little evident highway drainage along the downhill stretch from Highlands Boulevard.

Surface water runoff, generated from hard standing surfaces, would follow the channel of the road. In the event that the rate or volume of flow is increased, such as during an intense rainfall event, it is likely that water would exceed the capacity of the road channel and flow towards the properties on the northern side of Highlands Boulevard and bottom of the hill on Vardon Drive.

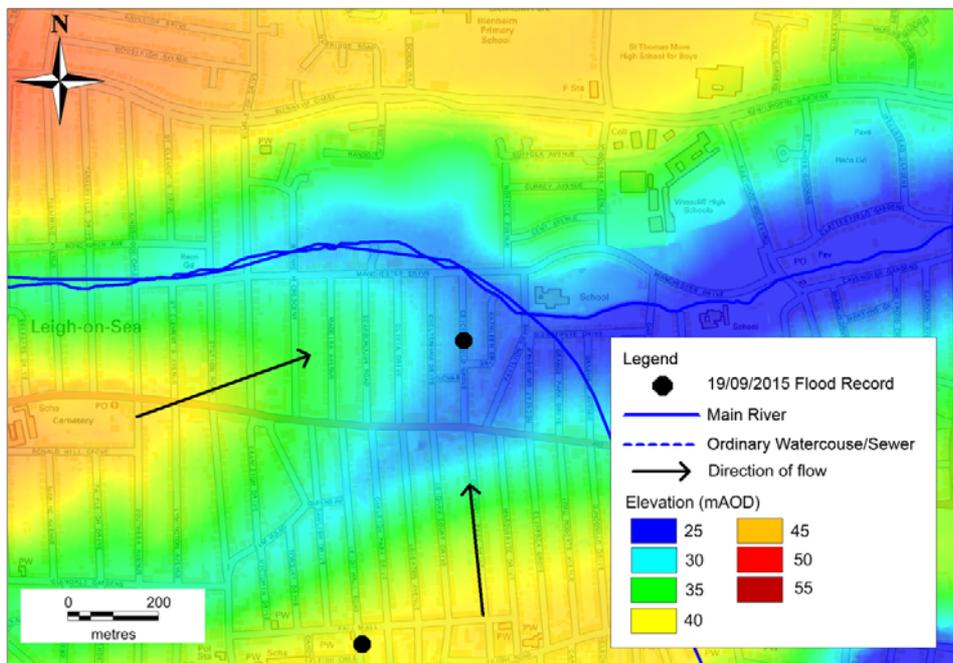
**Figure 3-4: Topography of Cricketfield Grove and surrounding area
Contains Ordnance Survey data © Crown copyright and database right 2014**

Figure 3-4 shows Cricketfield Grove to be located within a topographical depression associated with the Prittle Brook floodplain. Cricketfield Grove lies at approximately 25 mAOD with relatively steep slopes to the north and west reaching approximately 40 mAOD. The street itself is relatively level, surface water from the surrounding area is likely to pond here during heavy rainfall, particularly if the drainage network is at capacity.

Additionally, it has been noted that parked cars along most of the street present obstructions to gully cleaning vehicles. This can prevent the gullies being jetted as regularly as they are scheduled to be and impede effective road drainage. The council contractor's gully cleansing records show 11 gullies were checked on Cricketfield Grove on 12th May 2014. One gully was not cleaned due to a parked car and all the others were running clear at that time.

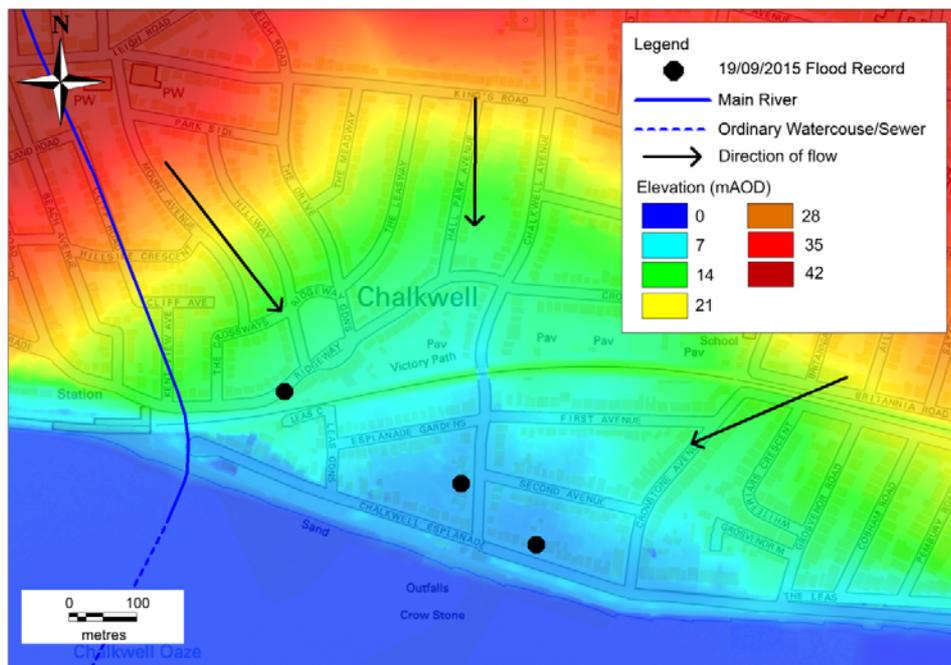
Figure 3-5: Topography of Chalkwell and surrounding area
 Contains Ordnance Survey data © Crown copyright and database right 2014

Figure 3-5 shows that Chalkwell Esplanade is at a low point in the local topography, with an elevation of approximately 4 mAOD. The low lying land, predominantly along the coastline, extends inland in the Chalkwell area. To the north of the affected area, the land rises rapidly at a gradient of approximately 1:20 to a higher elevation of approximately 40 mAOD.

The property flooding along Chalkwell Esplanade was a basement car park which has flooded previously due to its low threshold level. It is reported that a new flood barrier had been installed at this location, but failed to work on 19th September 2014.

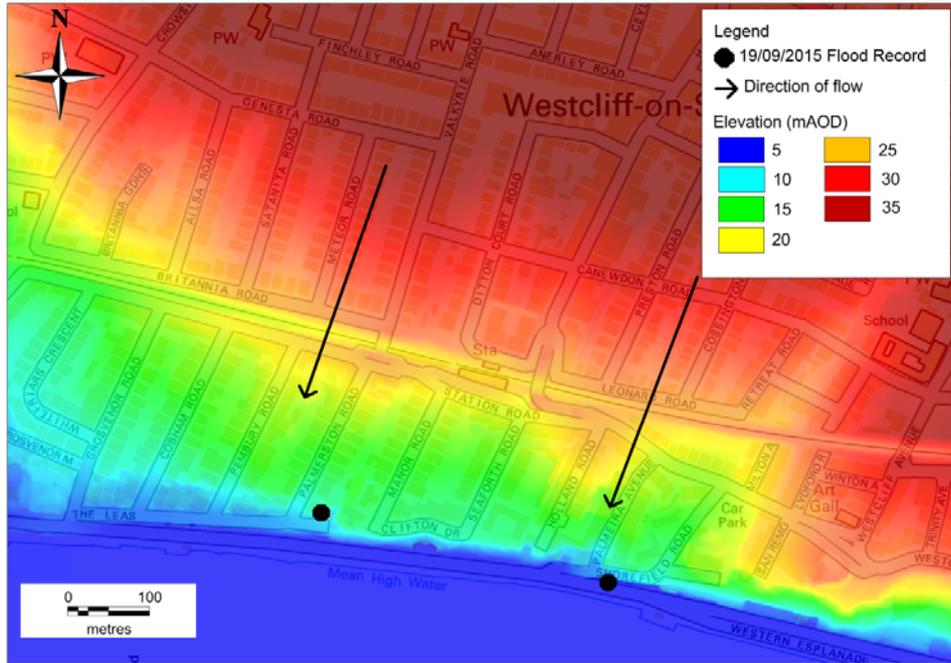
**Figure 3-6: Topography of Western Esplanade and surrounding area
Contains Ordnance Survey data © Crown copyright and database right 2014**

Surface water from Western Esplanade and The Leas (where incidents were recorded on 19th September 2014) drains via a separate surface water network that discharges via a gravity outfall to the Thames Estuary. Due to the high tides at the time of the storm, it is likely that the capacity of the network was reduced by tide locking of the outfall. Water would therefore not have been able to discharge freely from the network. As the drainage area is heavily urbanised, runoff would be rapid. The capacity of the network would therefore reach capacity shortly after the rainfall. Both incidents occurred close to junctions in the network which would support this as a cause of flooding.

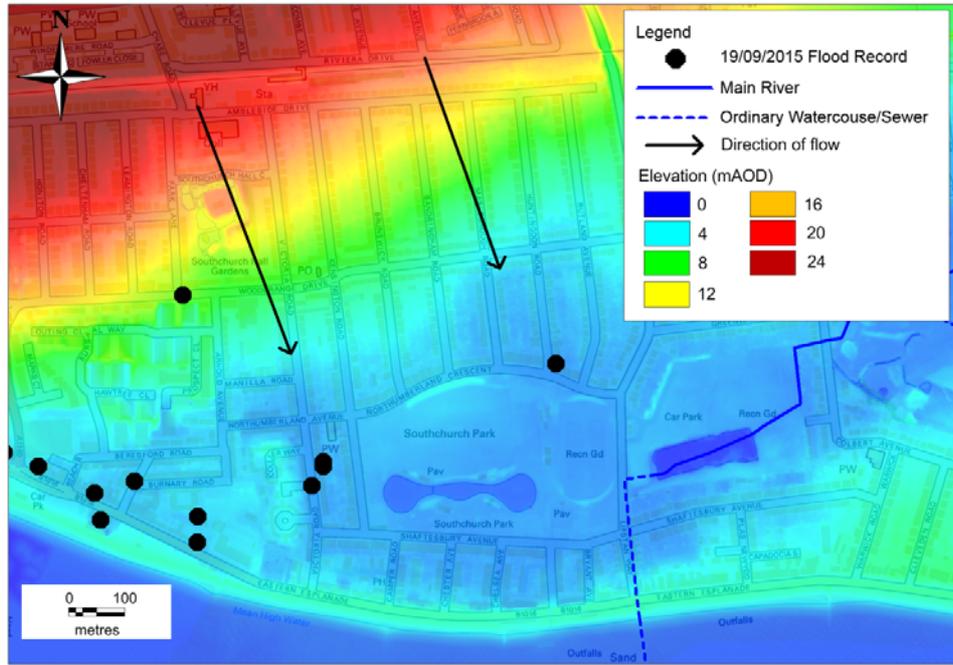
**Figure 3-7 Topography around Northumberland Crescent
Contains Ordnance Survey data © Crown copyright and database right 2014**

The local surface water drainage network flows from Northumberland Crescent and the surrounding residential areas in an easterly direction, before turning south at Lifstan Way. The site of flooding sits at a junction in the sewage network where two surface water sewers meet, which may be creating a pinch point during heavy storm events. Surface water is drained by gravity, or is pumped by the Lifstan Way Pumping Station at times of high tide. A pressured surface water sewer also passes beneath Northumberland Crescent, before crossing Southchurch Park and discharging via the Lifstan Way Pumping Station. Anglian Water has completed surveys of the surface and foul network within the area. Tree roots were found to be blocking the surface water gullies at the junction of Huntingdon Road and Northumberland Crescent.

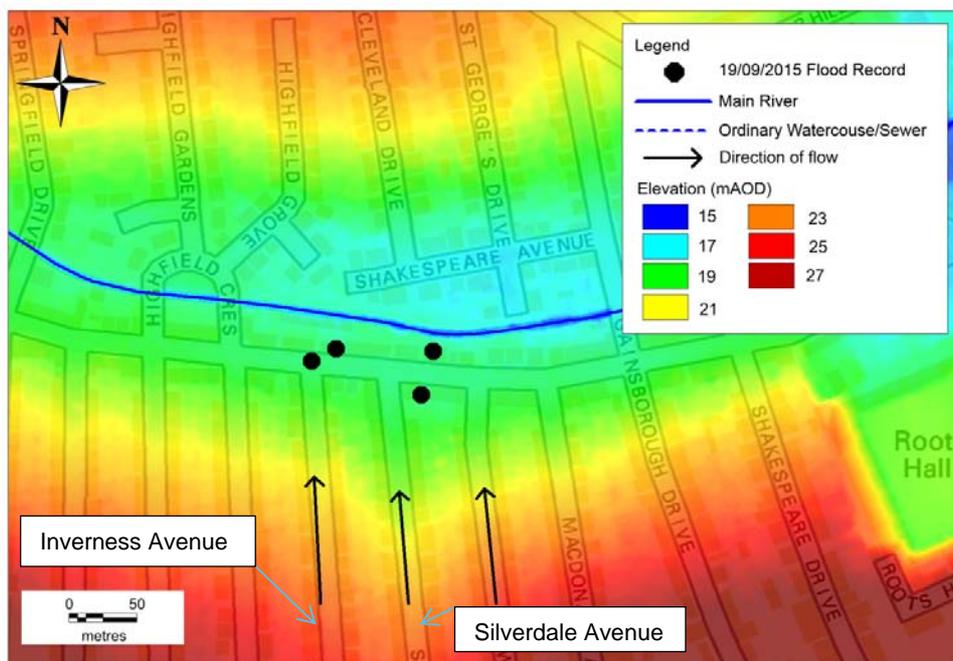
**Figure 3-8: Topography of Fairfax Drive and surrounding area
Contains Ordnance Survey data © Crown copyright and database right 2014**

Fairfax Drive lies at approximately 17-19 mAOD and is relatively flat, following the floodplain of the Prittle Brook as shown in Figure 3-8. To the north and south of Fairfax Drive the land slopes upwards extending to 25 mAOD. As a result, surface water will be channelled towards this location in heavy rainfall events.

Video footage of the 19th September 2014 provided by a business owner shows significant flooding in the road as people are seen bailing water from his property. A parking layby located in front of some of the worst affected properties does not currently have any drainage and properties have very low thresholds so as surface water accumulates, it will tend to flow towards properties once it overtops the kerb level.

There are a number of surface water sewers in the area which drain towards Fairfax Drive from the south. These surface waters discharge via sewer outfalls into Prittle Brook. High water levels in Prittle Brook would potentially restrict the surface

water outfalls, impeding the highway drainage. Likewise, debris accumulating within the surface water drainage network could result in blockages.

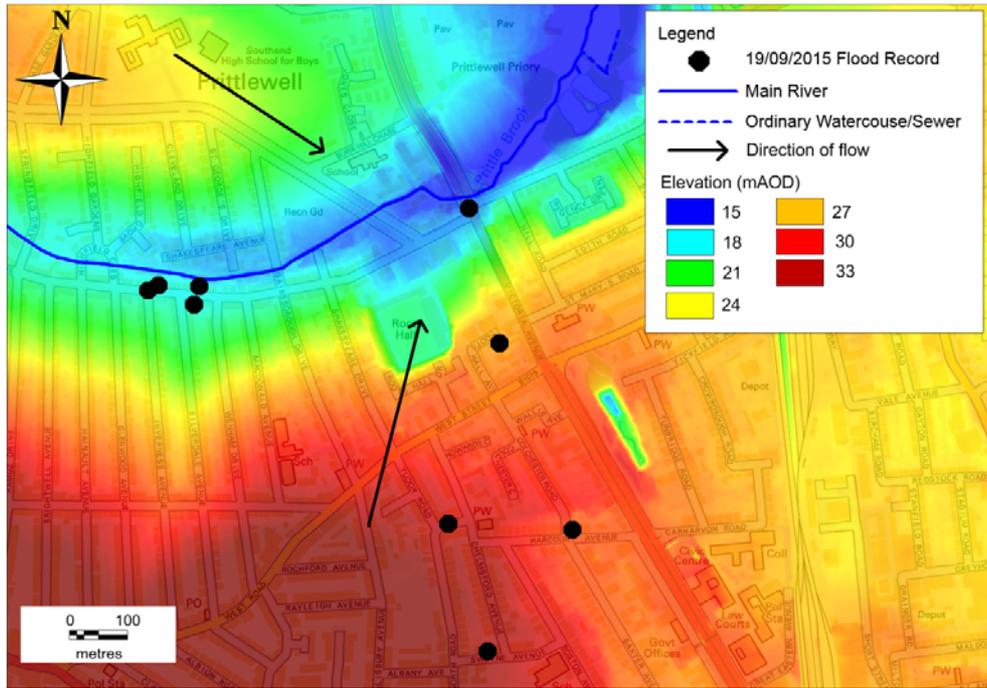
Figure 3-9: Topography of central Southend area
Contains Ordnance Survey data © Crown copyright and database right 2014

Across the central Southend area, the land tends to slope from the south towards Prittle Brook. Elevations decrease from approximately 35 mAOD to 11 mAOD at Prittle Brook (Figure 3-9).

A reported incident on the corner of Harcourt Avenue and Colchester Road is located close to a change in direction of the surface water sewer, which may be creating a pinch point at this location.

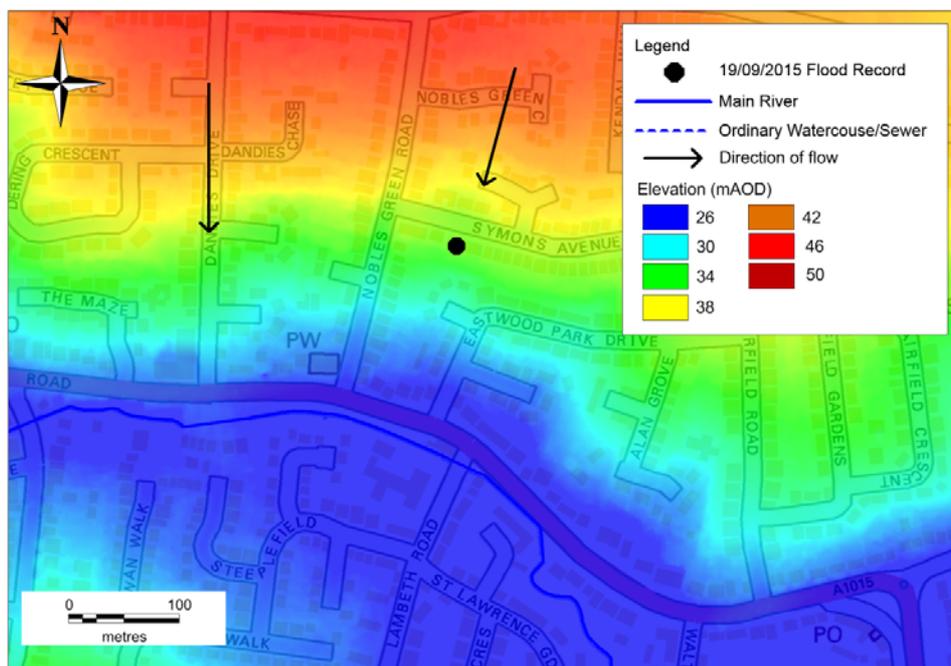
**Figure 3-10: Topography of Symons Avenue area
Contains Ordnance Survey data © Crown copyright and database right 2014**

Land to the north of Symons Avenue rises upwards to approximately 50 mAOD at Green lane. From here the land slopes continually down towards Eastwood Brook passing Symons Avenue at 35-40 mAOD (Figure 3-10). The camber of the road slopes to the south. On the southern side of the road, driveways slope downwards towards the properties leaving them vulnerable to surface water runoff during rainfall events.

Following previous flood events, it is reported that a number of new gullies were fitted in Symons Avenue in an attempt to alleviate the problem. There is conflicting anecdotal evidence as to whether flooding has been alleviated with community members suggesting there was a marked improvement with some of the gullies working efficiently. However a gully outside house number 20 was observed to start back flowing whilst one opposite house number 20 did not appear to take water at all leaving the road full of water and several inches flowing into residents' garages.

SBC have cleared and replaced a gully within Symonds Avenue that was blocked at the time of flooding.
