The London Tilbury and Southend Railway constructed the first railway to Southend, which reached Southend Central in 1856. This ran along the coast from Leigh on Sea to the outskirts of what is now Chalkwell, before continuing slightly further inland to reach its original terminus.

We will now focus on the southern approach ramp, the Council owned structure, which we shall henceforth refer to as Chalkwell Ramp.

## Detailed Inspection

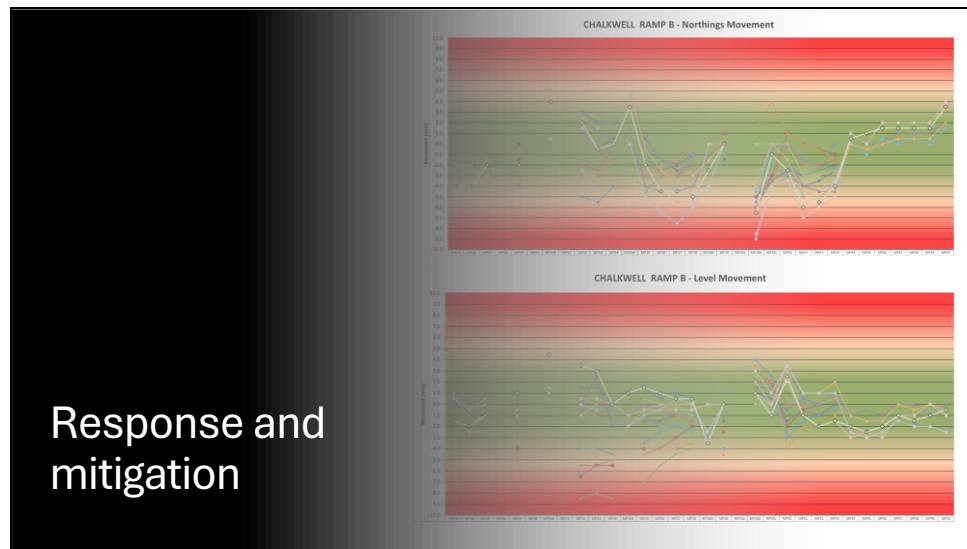
The structure was subject to a detailed inspection in the summer of 2020, which included access onto Network Rail property. Whilst there is an easement in place for the Council to access the structure, this still has to be arranged through Network Rail's Asset Protection Service, which involves various assurance activities, all taking some time.

It was concluded in this report that the structure in overall terms was in a very poor condition and effectively life expired, with there being a need to manage the risk posed by it until such a time as it could be replaced.

In initial response, the Council began implemented various measures, including:

- The installation of hoarding on railway property, to permit ease of ongoing access for maintenance and inspection activity.
- Increasing the inspection frequency of the structure to monthly, such that changes in the condition of the structure could be recorded.
- Target monitoring of the structure, to understand how it moves, whether movement is ongoing and capture any diverging trends. Two examples of the data output from this monitoring are shown on the screen, with the difference from the centre of each table representing the movement since the base readings were taken.

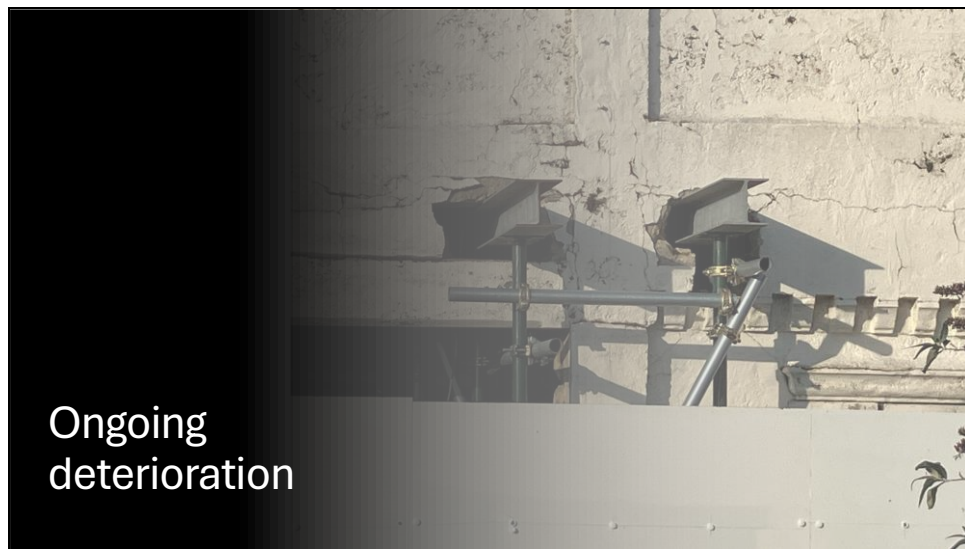
The increased frequency of inspection work detected a gradual ongoing deterioration in the condition of the structure, from an already very poor baseline when these commenced. Key issue identified included:

- The further proliferation of fracturing of the reinforced concrete structure.
- Spalling of significant segments of loose concrete over public areas, posing a significant risk to members of the public.
- Instability and severe fracturing of infill walling on the seaward side of the structure.
- Ongoing structural movement, with certain targets demonstrating diverging movement relative to general trends, coincident in areas where other significant defects were present.

Further mitigation has been installed as these defects have either propagated, or emerged, including:

- The installation of hoarding on the seaward side of the structure.
- Additional local propping being installed.
- Removal of loose concrete from height.
- Regular maintenance of the hoarding.

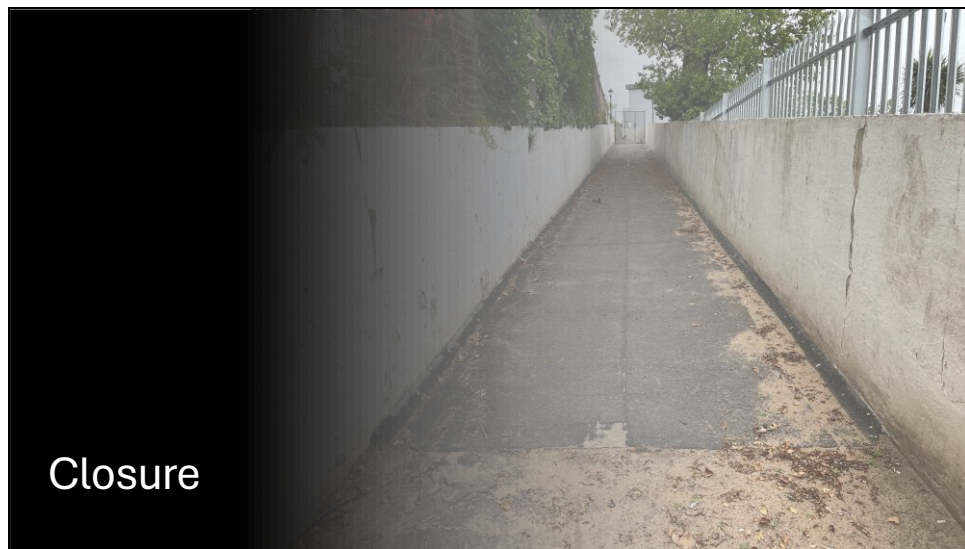
With the increased levels of deterioration from the already severe level seen during the 2020 detailed inspection, it was decided to explore options for providing comprehensive propping to the entire structure throughout. The purpose of such a scheme would be to mitigate ongoing risk permitting the structure to remain open in the short-term, pending the development of a replacement structure.

Various options were explored including infilling the voids beneath the lower (seaward) ramp and extensive propping from railway property to the upper (landward) ramp. In practice, such a scheme, whilst not impossible, would represent a significant investment of capital, be very difficult to construct and with difficulties in gaining railway access and would take some time to implement – with no further mitigation of the risk in the intervening period.

Whilst not impossible, it was considered spending time, effort and resource, on further temporary stabilising works, would not be in the public's best interest and instead developing a fully accessible replacement ought to be prioritised.
